General Information

Make	Toyota	Model	Wigo
YOM	2021	Odo Meter Reading	50,168
Registration No.	GAT8869	Chassis No.	MHKA4DF5FMJ055094
CC	1.0	Transmission	A/T
Fuel Type	Gas	Type of Body	Hatchback
Colour	Orange

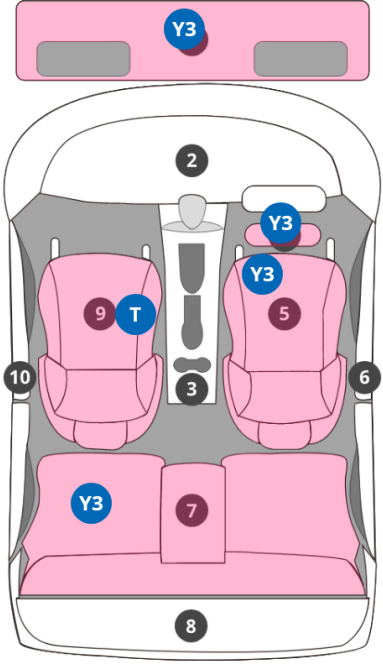
Interior Evaluation : C	Exterior Evaluation : E

<p>a : Cut, Fray d : Loose, Deformed k : Animal Hair s : Smell t : Cigarette Burns x : Defective y : Stain</p>

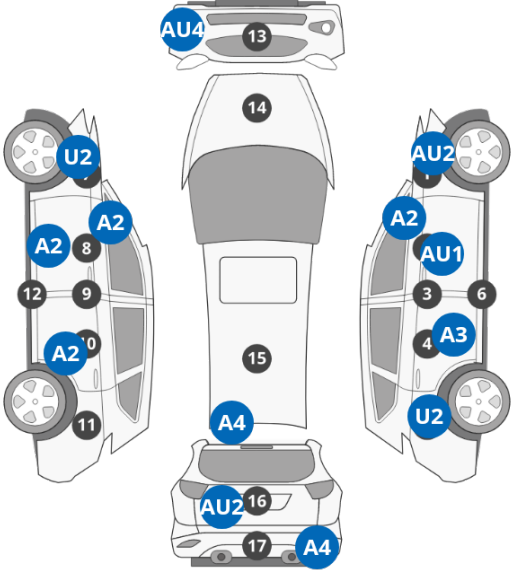
<p>A : Scratch AU : Scratch & Dent B : Modified C : Corrosion G : Stone chip P : Faded S : Rust SC : Rust & Corrosion U : Dent X : Defective Y : Crack, Gap</p>
<p>Remarks Ceiling - Grime - Medium / (R) Front Seat - Grime - Medium / Mat Other - Grime - Medium / Rear Seat - Grime - Medium / (L) Front Seat - Cigarette Burns - Burnt</p>	<p>Remarks (R) Front Fender - Repair Traces - Yes / (L) Rear Fender - Repair Traces - Yes / Overall Exterior - Faded(Color, Gloss) - Yes / (L) Mirror - Scratch - Small / (L) Front Fender, Molding - Dent - Small / (R) Mirror - Scratch - Small / (R) Front Fender, Molding - Scratch & Dent - Small / (R) Rear Door, Molding - Scratch - Medium / (R) Front Door, Molding - Scratch & Dent - Minimal / Trunk Hood, Rear Gate - Scratch & Dent - Small / (R) Rear Fender, Molding - Dent - Small / Rear Bumper, Lamps, Panels - Scratch - Large / (L) Rear Door, Molding - Scratch - Small / (L) Front Door, Molding - Scratch - Small / Roof Spoiler, Molding - Scratch - Large / Front Bumper, Grille, Lamps - Scratch & Dent - Large</p>
