General Information

Make	Nissan	Model	NV350
YOM	2021	Odo Meter Reading	43,400
Registration No.	NEP6581	Chassis No.	JN1TC2E26Z0065291
CC	2.5	Transmission	M/T
Fuel Type	Diesel	Type of Body	Van
Colour	Silver

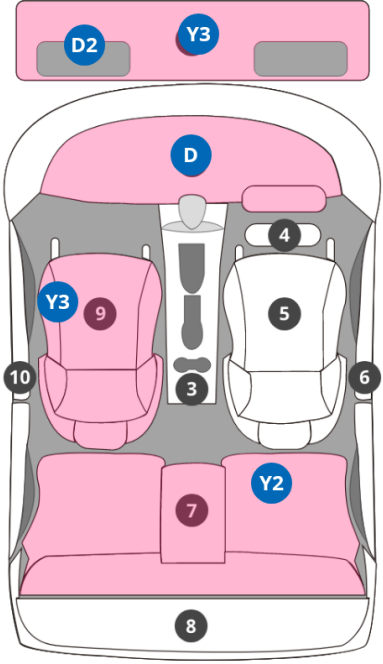
Interior Evaluation : B	Exterior Evaluation : E

<p>a : Cut, Fray d : Loose, Deformed k : Animal Hair s : Smell t : Cigarette Burns x : Defective y : Stain</p>

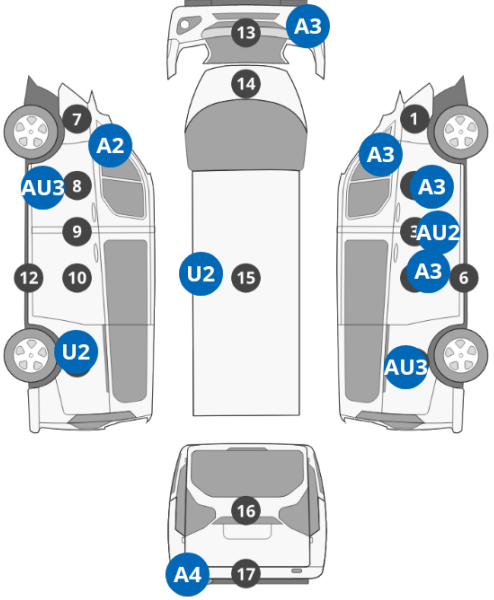
<p>A : Scratch AU : Scratch & Dent B : Modified C : Corrosion G : Stone chip P : Faded S : Rust SC : Rust & Corrosion U : Dent X : Defective Y : Crack, Gap</p>
<p>Remarks Ceiling - Grime - Medium / Sunvisor, Sunglass Holder - Crinkle - Small / Rear Seat - Grime - Small / (L) Front Seat - Grime - Medium / Dashboard - Traces of Adhesive Tape - Yes</p>	<p>Remarks (L) Front Door, Molding - Scratch & Dent - Medium / (L) Rear Fender, Molding - Dent - Small / (L) Mirror - Scratch - Small / Front Bumper, Grille, Lamps - Scratch - Medium / (R) Mirror - Scratch - Medium / (R) Front Door, Molding - Scratch - Medium / (R) Center Panel - Scratch & Dent - Small / (R) Rear Door, Molding - Scratch - Medium / (R) Rear Fender, Molding - Scratch & Dent - Medium / Rear Bumper, Lamps, Panels - Scratch - Large / Roof - Dent - Small</p>
