General Information

Make	Toyota	Model	Vios
YOM	2020	Odo Meter Reading	100,775
Registration No.	IAD7041	Chassis No.	PA1B18F31L4116718
CC	1.3	Transmission	CVT
Fuel Type	Gas	Type of Body	Sedan
Colour	Red Mica Metallic

Body / Panel Condition

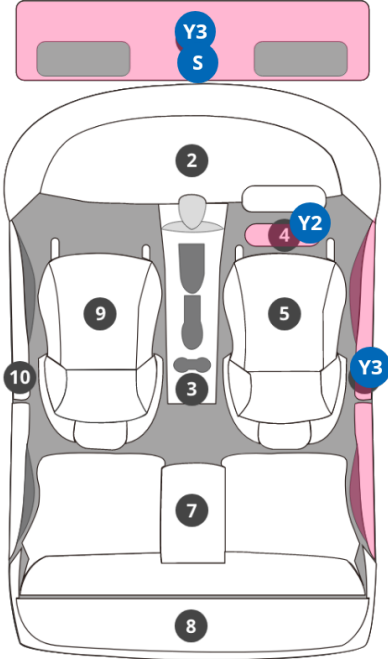
Interior Evaluation : B	Exterior Evaluation : D

<p>a : Cut, Fray d : Loose, Deformed k : Animal Hair s : Smell t : Cigarette Burns x : Defective y : Stain</p>

<p>A : Scratch AU : Scratch & Dent B : Modified C : Corrosion G : Stone chip P : Faded S : Rust SC : Rust & Corrosion U : Dent X : Defective Y : Crack, Gap</p>
<p>Remarks Ceiling - Grime - Medium / (R) Front Trim - Grime - Medium / (R) Front Floor Mat - Grime - Small / Overall Interior - Smell - Yes</p>	<p>Remarks (L) Rear Fender, Molding - Scratch & Dent - Small / (L) Rear Door, Molding - Scratch - Medium / Rear Bumper, Lamps, Panels - Scratch & Dent - Large / Trunk Hood, Rear Gate - Scratch - Minimal / (L) Front Door, Molding - Scratch & Dent - Minimal / (L) Front Fender, Molding - Scratch - Small / Front Bumper, Grille, Lamps - Scratch - Medium / Bonnet, Headlight - Scratch - Small / (R) Mirror - Scratch - Minimal / (R) Rear Door, Molding - Scratch - Small / (R) Front Door, Molding - Scratch - Medium / (R) Rear Fender, Molding - Scratch & Dent - Small / Roof - Dent - Minimal</p>
