General Information

Make	Mitsubishi	Model	Xpander
YOM	2019	Odo Meter Reading	28,500
Registration No.	CAU1067	Chassis No.	MK2XRNC1WKN073986
CC	1.5	Transmission	A/T
Fuel Type	Gas	Type of Body	Wagon
Colour	Black

Body / Panel Condition

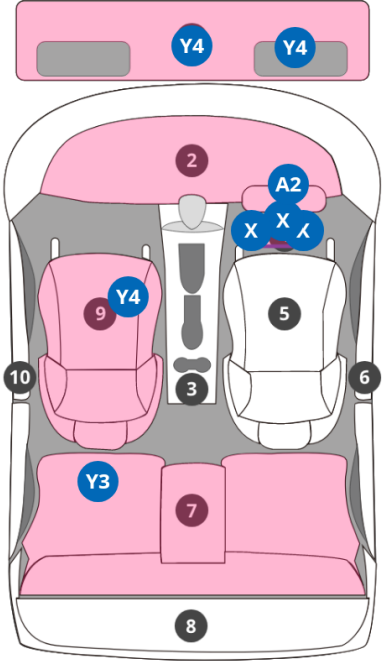
Interior Evaluation : C	Exterior Evaluation : D

<p>a : Cut, Fray d : Loose, Deformed k : Animal Hair s : Smell t : Cigarette Burns x : Defective y : Stain</p>

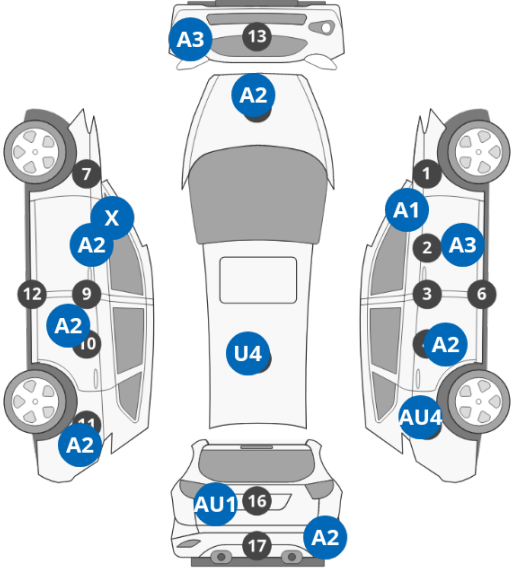
<p>A : Scratch AU : Scratch & Dent B : Modified C : Corrosion G : Stone chip P : Faded S : Rust SC : Rust & Corrosion U : Dent X : Defective Y : Crack, Gap</p>
<p>Remarks Sunvisor, Sunglass Holder - Grime - Large / Ceiling - Grime - Large / (R) Front Floor Mat - Missing - Yes / Mat Other - Missing - Yes / (L) Front Floor Mat - Missing - Yes / Rear Seat - Grime - Medium / (L) Front Seat - Grime - Large / Steering Wheel - Worn, Peel, Crack - Small</p>	<p>Remarks Bonnet, Headlight - Scratch - Small / (R) Front Door, Molding - Scratch - Medium / (R) Rear Door, Molding - Scratch - Small / (R) Rear Fender, Molding - Scratch & Dent - Large / Rear Bumper, Lamps, Panels - Scratch - Small / Trunk Hood, Rear Gate - Scratch & Dent - Minimal / (L) Rear Fender, Molding - Scratch - Small / (L) Rear Door, Molding - Scratch - Small / (L) Front Door, Molding - Scratch - Small / Front Bumper, Grille, Lamps - Scratch - Medium / (R) Mirror - Scratch - Minimal / Roof - Dent - Large / (L) Mirror - Stuck - Yes</p>
