## General Information

| Make | Toyota | Model | Vios |

## Body / Panel Condition

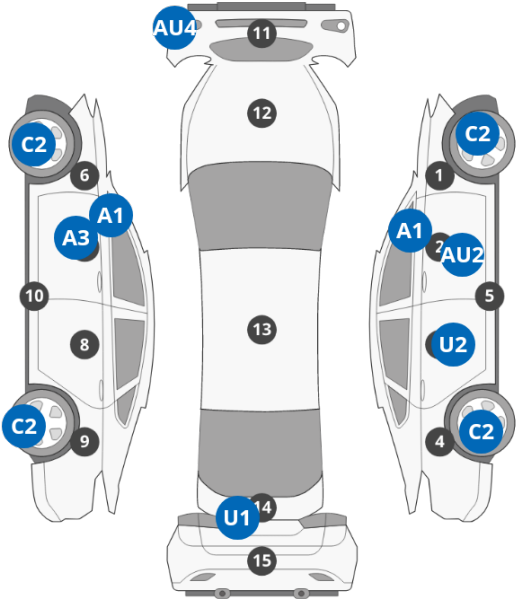
| Interior Evaluation : <span style="color: red; font-weight: bold;">A</span> | Exterior Evaluation : <span style="color: red; font-weight: bold;">C</span> |
|---|---|
| <b>Remarks</b><br>Defects not found | <b>Remarks</b><br>(L) Front Door, Molding - Scratch - Medium / Front Bumper, Grille, Lamps - Scratch & Dent - Large / (R) Front Door, Molding - Scratch & Dent - Small / (R) Rear Door, Molding - Dent - Small / (R) Mirror - Scratch, Peeled - Minimal / Trunk Hood, Rear Gate - Dent - Minimal / (L) Mirror - Scratch, Peeled - Minimal / (L) Front Wheel, Cover - Scratch, Corrosion - Small / (L) Rear Wheel, Cover - Scratch, Corrosion - Small / (R) Rear Wheel, Cover - Scratch, Corrosion - Small / (R) Front Wheel, Cover - Scratch, Corrosion - Small |

| Inspector Notes |
|---|
| reverse camera notmworking/ no retractable side mirror / swirl marks and hairline scratches present/ |
