General Information

Make	Suzuki	Model	Ertiga
YOM	2021	Odo Meter Reading	50,090
Registration No.	CBM2669	Chassis No.	MHYNC22S9MJ106434
CC	1.5	Transmission	M/T
Fuel Type	Gas	Type of Body	MPV
Colour	White

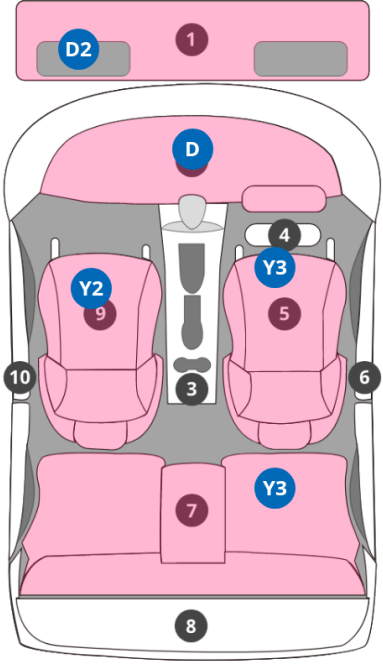
Interior Evaluation : B	Exterior Evaluation : B

<p>a : Cut, Fray d : Loose, Deformed k : Animal Hair s : Smell t : Cigarette Burns x : Defective y : Stain</p>

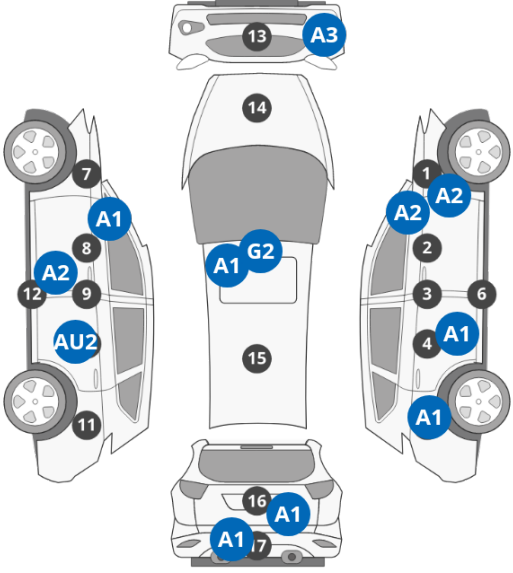
<p>A : Scratch AU : Scratch & Dent B : Modified C : Corrosion G : Stone chip P : Faded S : Rust SC : Rust & Corrosion U : Dent X : Defective Y : Crack, Gap</p>
<p>Remarks (R) Front Seat - Grime - Medium / Rear Seat - Grime - Medium / (L) Front Seat - Grime - Small / Dashboard - Traces of Adhesive Tape - Yes / Sunvisor, Sunglass Holder - Crinkle - Small</p>	<p>Remarks (R) Front Fender - Repair Traces - Yes / (R) Rear Fender, Molding - Scratch - Minimal / (R) Mirror - Scratch - Small / (R) Front Fender, Molding - Scratch - Small / (R) Rear Door, Molding - Scratch - Minimal / Rear Bumper, Lamps, Panels - Scratch - Minimal / Trunk Hood, Rear Gate - Scratch - Minimal / (L) Rear Door, Molding - Scratch & Dent - Small / (L) Front Door, Molding - Scratch - Small / (L) Mirror - Scratch - Minimal / Front Bumper, Grille, Lamps - Scratch - Medium / Roof - Scratch - Minimal / Front Windshield - Scratch, Stone chip - Small</p>
