## General Information

<b>Make</b>	Toyota	<b>Model</b>	Fortuner
<b>YOM</b>	2017	<b>Odo Meter Reading</b>	135,525
<b>Registration No.</b>	DAB4338	<b>Chassis No.</b>	MHFJB8GS55G1521390
<b>CC</b>	2.4	<b>Transmission</b>	A/T
<b>Fuel Type</b>	Diesel	<b>Type of Body</b>	SUV
<b>Colour</b>	Brown

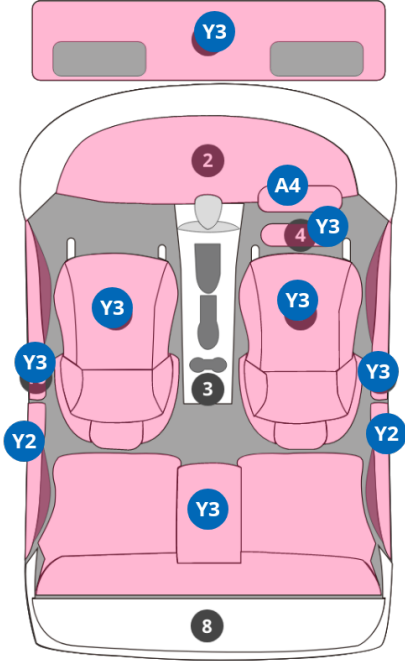
<p><b>a</b> : Cut, Fray <b>d</b> : Loose, Deformed <b>k</b> : Animal Hair <b>s</b> : Smell <b>t</b> : Cigarette Burns <b>x</b> : Defective <b>y</b> : Stain</p>

<p><b>A</b> : Scratch <b>AU</b> : Scratch &amp; Dent <b>B</b> : Modified <b>C</b> : Corrosion <b>G</b> : Stone chip <b>P</b> : Faded <b>S</b> : Rust <b>SC</b> : Rust &amp; Corrosion <b>U</b> : Dent <b>X</b> : Defective <b>Y</b> : Crack, Gap</p>
<p><b>Remarks</b>          Ceiling - Grime - Medium / (R) Front Trim - Grime - Medium / (R) Front Floor Mat - Grime - Medium / (R) Front Seat - Grime - Medium / (R) Rear Trim - Grime - Small / Rear Seat - Grime - Medium / (L) Rear Trim - Grime - Small / (L) Front Trim - Grime - Medium / (L) Front Seat - Grime - Medium / Steering Wheel - Worn, Peel, Crack - Large</p>	<p><b>Remarks</b>          (L) Mirror - Scratch - Minimal / (R) Rear Door, Molding - Scratch &amp; Dent - Large / (R) Front Door, Molding - Scratch - Medium / (R) Rear Fender, Molding - Scratch &amp; Dent - Large / Trunk Hood, Rear Gate - Scratch &amp; Dent - Medium / Rear Bumper, Lamps, Panels - Scratch - Large / (L) Rear Fender, Molding - Scratch - Small / (L) Front Door, Molding - Scratch - Minimal / (L) Front Fender, Molding - Scratch - Small / (L) Rear Door, Molding - Scratch &amp; Dent - Large / Front Bumper, Grille, Lamps - Scratch - Large / Bonnet, Headlight - Scratch - Small / Roof - Dent - Small / (R) Front Fender, Molding - Scratch - Medium</p>
