General Information

Make	Toyota	Model	Vios
YOM	2021	Odo Meter Reading	93,844
Registration No.	DAT6843	Chassis No.	PA1B118F36L4128900
CC	1.3	Transmission	CVT
Fuel Type	Gas	Type of Body	Sedan
Colour	Blackish Red Mica

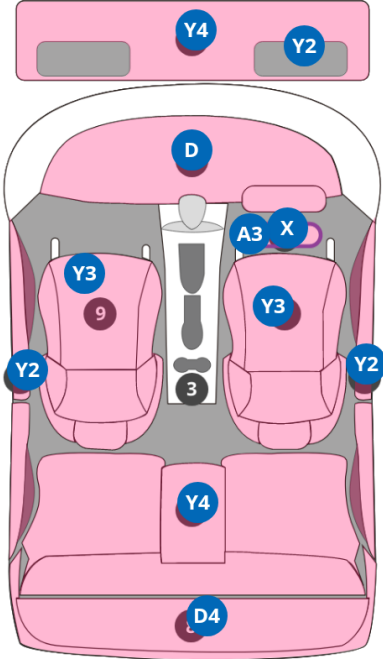
<p>a : Cut, Fray d : Loose, Deformed k : Animal Hair s : Smell t : Cigarette Burns x : Defective y : Stain</p>

<p>A : Scratch AU : Scratch & Dent B : Modified C : Corrosion G : Stone chip P : Faded S : Rust SC : Rust & Corrosion U : Dent X : Defective Y : Crack, Gap</p>
<p>Remarks Ceiling - Grime - Large / Sunvisor, Sunglass Holder - Grime - Small / (R) Front Trim - Grime - Small / (R) Front Seat - Grime - Medium / Rear Seat - Grime - Large / Mat Other - Missing - Yes / Trunk Room - Loose, Deformed - Large / (L) Front Floor Mat - Cut, Crack - Medium / (L) Front Seat - Grime - Medium / Dashboard - Traces of Adhesive Tape - Yes / (L) Front Trim - Grime - Small</p>	<p>Remarks Front Bumper, Grille, Lamps - Scratch & Dent - Large / Bonnet, Headlight - Scratch - Large / (R) Front Fender, Molding - Scratch & Dent - Small / (R) Mirror - Scratch - Small / (R) Rear Door, Molding - Scratch - Large / (R) Rear Fender, Molding - Scratch & Dent - Small / (R) Front Door, Molding - Scratch & Dent - Medium / Rear Bumper, Lamps, Panels - Scratch - Large / Trunk Hood, Rear Gate - Scratch & Dent - Small / (L) Rear Fender, Molding - Scratch - Small / Roof - Scratch & Dent - Small / (L) Mirror - Scratch - Small / (L) Rear Door, Molding - Scratch & Dent - Small / (L) Step, In-panel, Side Spoiler - Scratch & Dent - Small / (L) Front Door, Molding - Scratch - Large / (L) Front Fender, Molding - Scratch - Small</p>
