## General Information

| Make | Toyota | Model | Vios |
| Registration No. | NFR8692 | Chassis No. | PA1B18F3XR4257215 |

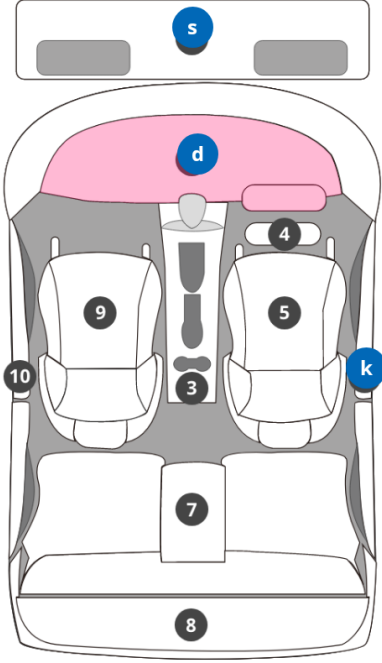
| Interior Evaluation : <b>B</b> | Exterior Evaluation : <b>B</b> |
| <p><b>Remarks</b><br/>Overall Interior - Smell - Yes / Dashboard - Traces of Adhesive Tape - Yes / Overall Interior - Animal Hair - Yes</p> | <p><b>Remarks</b><br/>Front Bumper, Grille, Lamps - Scratch - Medium / (R) Mirror - Scratch - Minimal / Rear Bumper, Lamps, Panels - Scratch - Medium</p> |

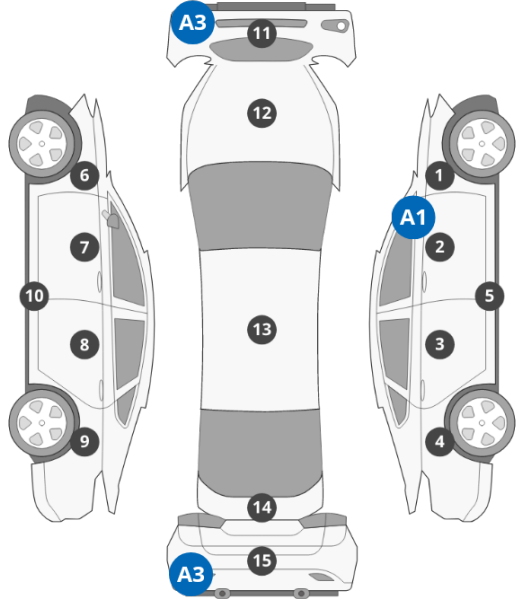
more light scratches around the exterior. Gap at the left rear bumper. trace of adhesive mark at the roof
