## General Information

| Make | Toyota | Model | Vios |
| YOM | 2024 | Mileage | 6,545 |

## Body / Panel Condition

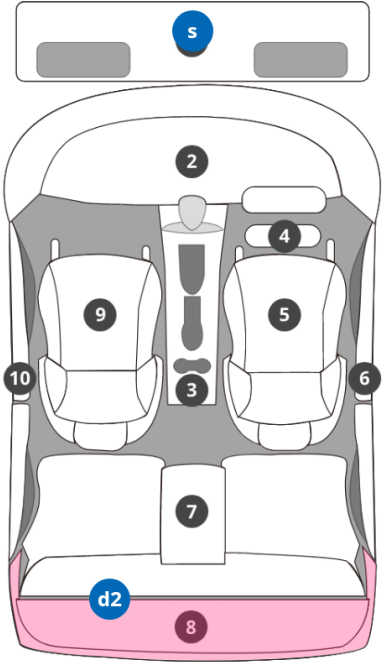
| Interior Evaluation : <span style="color: red; font-weight: bold;">B</span> | Exterior Evaluation : <span style="color: red; font-weight: bold;">B</span> |
| <b>Remarks</b><br>Overall Interior - Smell - Yes / Trunk Room - Loose, Deformed, Grime - Small | <b>Remarks</b><br>Bonnet, Headlight - Dent - Minimal / Rear Bumper, Lamps, Panels - Scratch - Medium / (R) Rear Door, Molding - Scratch - Small |

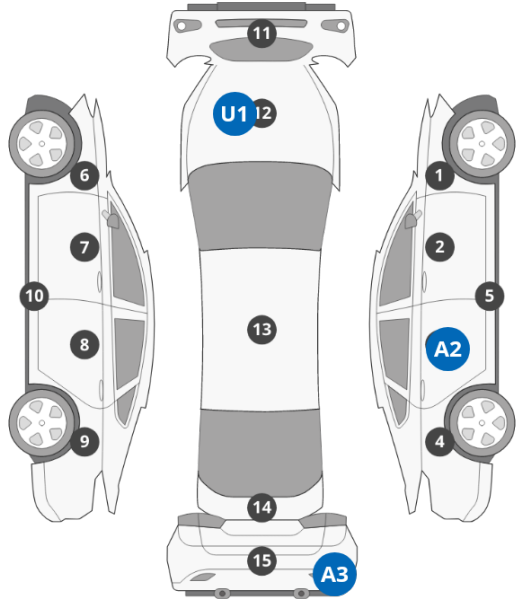
swirlmarks and hairline scratches around the exterior. scratch at the left rearbumper.
