## General Information

<b>Make</b>	Toyota	<b>Model</b>	Vios
<b>YOM</b>	2024	<b>Odo Meter Reading</b>	45,284
<b>Registration No.</b>	NIU9675	<b>Chassis No.</b>	PA1B18F39R4244780
<b>CC</b>	1.3	<b>Transmission</b>	CVT
<b>Fuel Type</b>	Gas	<b>Type of Body</b>	Sedan
<b>Colour</b>	Blue

## Body / Panel Condition

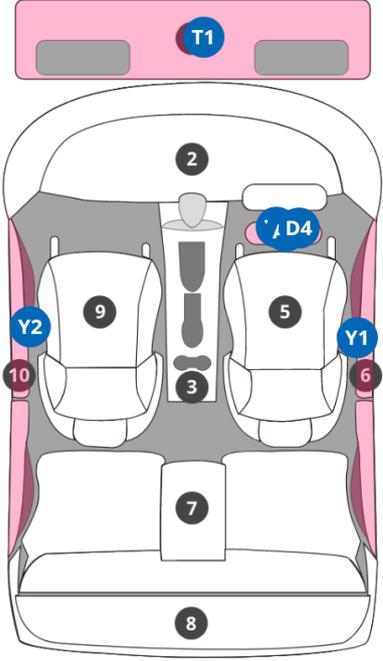
<b>Interior Evaluation :</b> <span style="float: right; color: red; font-weight: bold;">C</span>	<b>Exterior Evaluation :</b> <span style="float: right; color: red; font-weight: bold;">C</span>

<p><b>a</b> : Cut, Fray <b>d</b> : Loose, Deformed <b>k</b> : Animal Hair <b>s</b> : Smell <b>t</b> : Cigarette Burns <b>x</b> : Defective <b>y</b> : Stain</p>

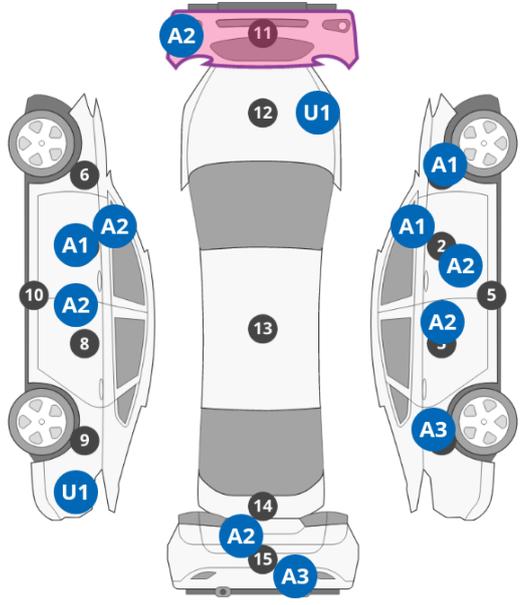
<p><b>A</b> : Scratch <b>AU</b> : Scratch &amp; Dent <b>B</b> : Modified <b>C</b> : Corrosion <b>G</b> : Stone chip <b>P</b> : Faded <b>S</b> : Rust <b>SC</b> : Rust &amp; Corrosion <b>U</b> : Dent <b>X</b> : Defective <b>Y</b> : Crack, Gap</p>
<p><b>Remarks</b> (R) Front Floor Mat - Grime - Small / (R) Front Trim - Grime - Minimal / (L) Front Floor Mat - Cut, Crack - Small / (L) Front Floor Mat - Worked - Large / (L) Front Trim - Grime - Small / Ceiling - Cigarette Burns - Burnt Minimal</p>	<p><b>Remarks</b> (L) Rear Door - Repair Traces - Yes / (L) Rear Fender - Repair Traces - Yes / (R) Mirror - Scratch - Minimal / (R) Rear Door, Molding - Scratch - Small / (R) Front Door, Molding - Scratch - Small / (R) Front Fender, Molding - Scratch - Minimal / (R) Rear Fender, Molding - Scratch - Medium / Rear Bumper, Lamps, Panels - Scratch - Medium / Trunk Hood, Rear Gate - Scratch - Small / (L) Rear Fender, Molding - Dent - Minimal / (L) Front Door, Molding - Scratch - Minimal / (L) Mirror - Scratch - Small / Front Bumper, Grille, Lamps - Repair mark - Yes / Front Bumper, Grille, Lamps - Scratch - Small / Bonnet, Headlight - Dent - Minimal / (L) Rear Door, Molding - Scratch - Small</p>
