General Information

Make	Toyota	Model	Raize
YOM	2022	Odo Meter Reading	31,075
Registration No.	EAF2236	Chassis No.	MHKAA1BA5NJ044080
CC	1.0	Transmission	CVT
Fuel Type	Gas	Type of Body	SUV
Colour	White

Body / Panel Condition

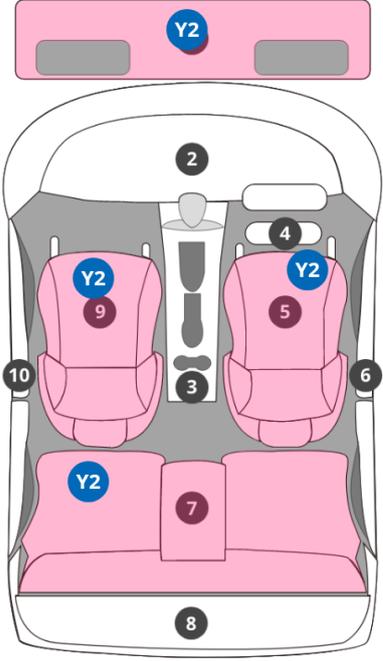
Interior Evaluation : A	Exterior Evaluation : B

<p>a : Cut, Fray d : Loose, Deformed k : Animal Hair s : Smell t : Cigarette Burns x : Defective y : Stain</p>

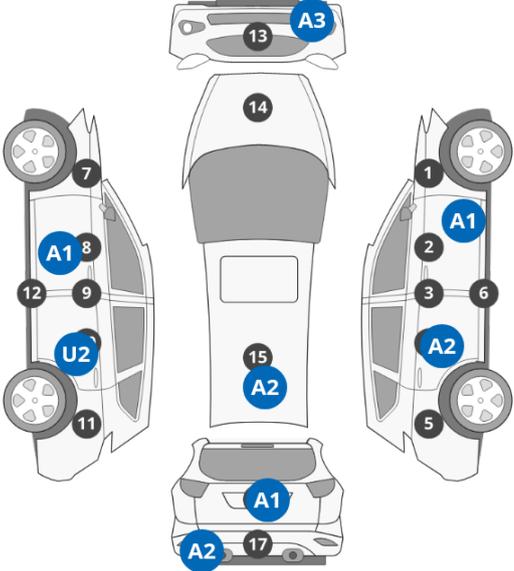
<p>A : Scratch AU : Scratch & Dent B : Modified C : Corrosion G : Stone chip P : Faded S : Rust SC : Rust & Corrosion U : Dent X : Defective Y : Crack, Gap</p>
<p>Remarks Rear Seat - Grime - Small / (R) Front Seat - Grime - Small / (L) Front Seat - Grime - Small / Ceiling - Grime - Small</p>	<p>Remarks Rear Bumper, Lamps, Panels - Scratch - Small / Front Bumper, Grille, Lamps - Scratch - Medium / (L) Rear Door, Molding - Dent - Small / (L) Front Door, Molding - Scratch - Minimal / (R) Rear Door, Molding - Scratch - Small / Roof - Scratch - Small / (R) Front Door, Molding - Scratch - Minimal / Trunk Hood, Rear Gate - Scratch - Minimal</p>
Frame Evaluation : A	Functional Evaluation : A
<p>Remarks Defects not found</p>	<p>Remarks Spare Key - Issue - Unexist</p>
