## General Information

| Make | Toyota | Model | Vios |

## Body / Panel Condition

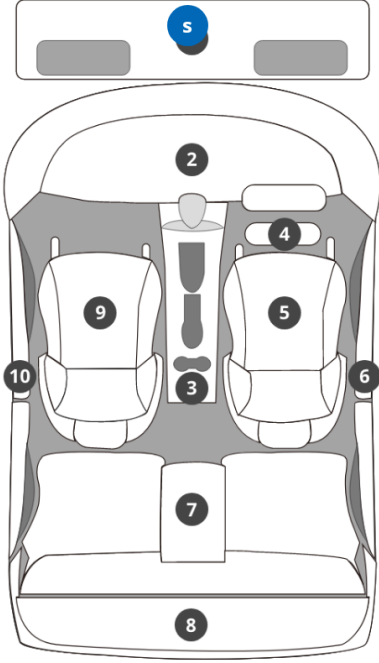
| Interior Evaluation : <b>B</b> | Exterior Evaluation : <b>C</b> |
| <b>Remarks</b><br>Overall Interior - Smell - Yes | <b>Remarks</b><br>Front Bumper, Grille, Lamps - Crack, Gap - Medium / (L)<br>Front Door, Molding - Scratch & Dent - Large / Rear<br>Bumper, Lamps, Panels - Scratch - Small / (R) Rear<br>Fender, Molding - Scratch - Small |

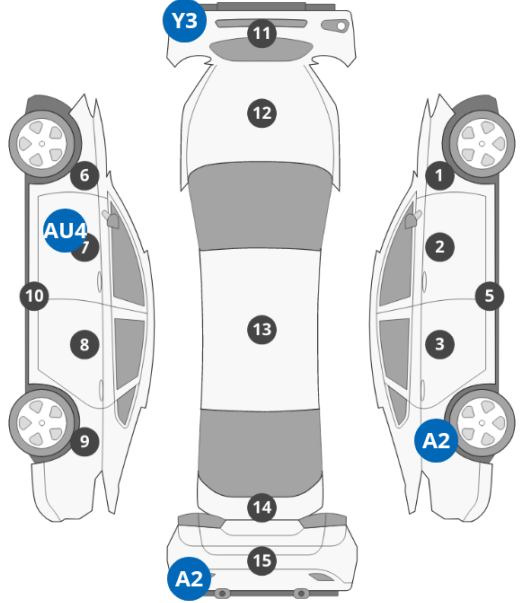
more light scratches around the exterior. dirty floor mats.
