## General Information

| Make | Toyota | Model | Vios |
| YOM | 2024 | Mileage | 4,223 |
| Registration No. | NFR9717 | Chassis No. | PA1B18F35R4259535 |

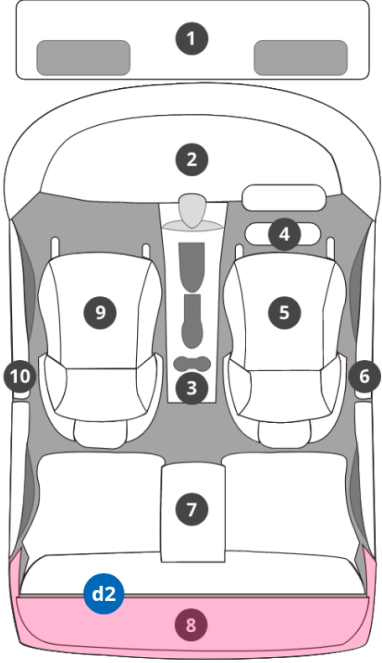
| <b>Remarks</b><br>Trunk Room - Loose, Deformed, Grime - Small | <b>Remarks</b><br>(L) Step, In-panel, Side Spoiler - Scratch - Small / (R) Rear Door, Molding - Scratch & Dent - Small / Rear Bumper, Lamps, Panels - Scratch - Small / Bonnet, Headlight - Scratch - Small |

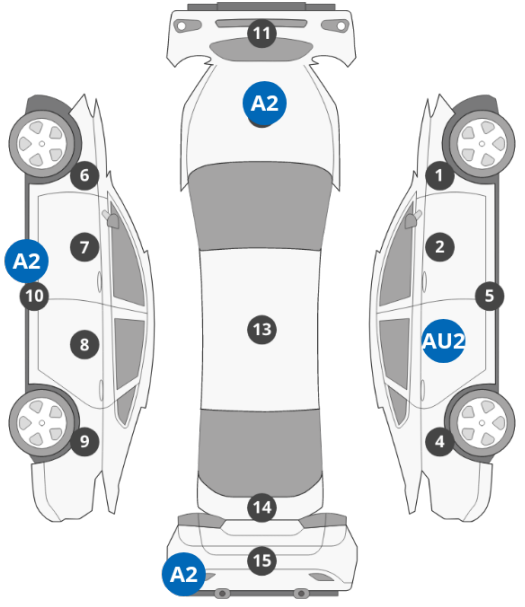
| Inspector Notes |
|---|
| swirlmarks and hairline scratches around the exterior. |
