General Information

Make	Toyota	Model	Innova
YOM	2020	Odo Meter Reading	64,400
Registration No.	NFY9190	Chassis No.	PA2JA8EM7L0080297
CC	2.8	Transmission	A/T
Fuel Type	Diesel	Type of Body	Wagon
Colour	Red Mica Metallic

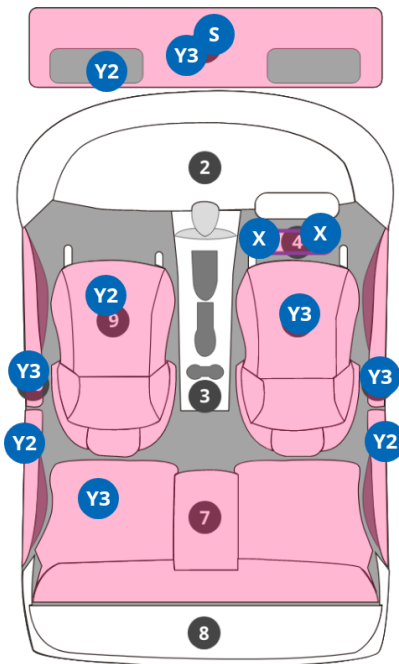
Interior Evaluation : C	Exterior Evaluation : C

<p>a : Cut, Fray d : Loose, Deformed k : Animal Hair s : Smell t : Cigarette Burns x : Defective y : Stain</p>

<p>A : Scratch AU : Scratch & Dent B : Modified C : Corrosion G : Stone chip P : Faded S : Rust SC : Rust & Corrosion U : Dent X : Defective Y : Crack, Gap</p>
<p>Remarks Overall Interior - Smell - Yes / Ceiling - Grime - Medium / (R) Front Floor Mat - Missing - Yes / (L) Front Floor Mat - Missing - Yes / (R) Front Seat - Grime - Medium / (R) Front Trim - Grime - Medium / (R) Rear Trim - Grime - Small / Rear Seat - Grime - Medium / (L) Rear Trim - Grime - Small / (L) Front Trim - Grime - Medium / (L) Front Seat - Grime - Small / Sunvisor, Sunglass Holder - Grime - Small</p>	<p>Remarks (L) Mirror - Scratch - Small / (L) Front Fender, Molding - Scratch - Small / (L) Front Door, Molding - Scratch - Small / (L) Rear Door, Molding - Scratch - Small / (L) Rear Fender, Molding - Scratch - Minimal / (R) Mirror - Scratch - Minimal / (R) Front Door, Molding - Scratch - Minimal / (R) Rear Door, Molding - Scratch - Minimal / (R) Rear Fender, Molding - Scratch - Small / Trunk Hood, Rear Gate - Scratch - Small / Rear Bumper, Lamps, Panels - Scratch - Medium / Front Bumper, Grille, Lamps - Repair mark - Yes / Front Bumper, Grille, Lamps - Scratch & Dent - Medium</p>
