## General Information

| Make | Honda | Model | BR-V |
| YOM | 2020 | Odo Meter Reading | 31,306 |
| Registration No. | NFW5097 | Chassis No. | PADDG1810LV301257 |

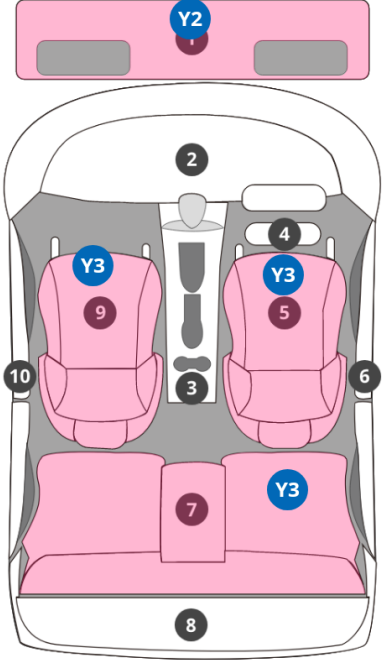
| <b>Remarks</b><br>(R) Front Seat - Grime - Medium / Ceiling - Grime - Small / Rear Seat - Grime - Medium / (L) Front Seat - Grime - Medium | <b>Remarks</b><br>(L) Rear Door - Repair Traces - Yes / (L) Rear Fender - Repair Traces - Yes / (L) Rear Fender, Molding - Scratch - Medium / Rear Bumper, Lamps, Panels - Scratch - Medium / (R) Rear Fender, Molding - Scratch - Medium / (R) Front Door, Molding - Scratch & Dent - Small / (R) Rear Door, Molding - Scratch & Dent - Medium / (R) Mirror - Scratch - Minimal / Front Bumper, Grille, Lamps - Dent - Large / (L) Front Fender, Molding - Scratch - Small / (L) Front Door, Molding - Scratch - Small / (L) Rear Door, Molding - Scratch - Small / Roof - Dent - Minimal / (R) Front Fender, Molding - Scratch - Medium |
