## General Information

| Make | Toyota | Model | Wigo |

## Body / Panel Condition

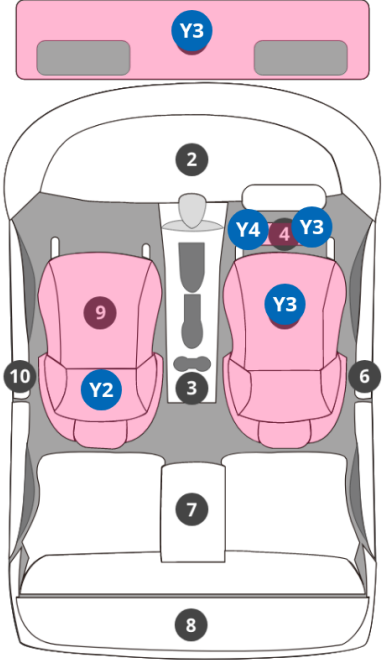
| Interior Evaluation : <b>C</b> | Exterior Evaluation : <b>B</b> |
|---|---|
| <p><b>Remarks</b><br/>Ceiling - Grime - Medium / (R) Front Floor Mat - Grime - Medium / (R) Front Seat - Grime - Medium / (L) Front Floor Mat - Grime - Large / (L) Front Seat - Grime - Small</p> | <p><b>Remarks</b><br/>(R) Rear Fender, Molding - Scratch - Small / Front Bumper, Grille, Lamps - Repair mark - Yes / Front Bumper, Grille, Lamps - Scratch - Medium / (L) Mirror - Scratch - Minimal / (L) Rear Door, Molding - Scratch - Small / (L) Front Door, Molding - Scratch - Minimal / (L) Front Fender, Molding - Scratch &amp; Dent - Minimal / Rear Bumper, Lamps, Panels - Scratch &amp; Dent - Medium / (R) Front Door, Molding - Scratch - Minimal / Bonnet, Headlight - Scratch - Minimal</p> |
