## General Information

| Make | Toyota | Model | Vios |

## Body / Panel Condition

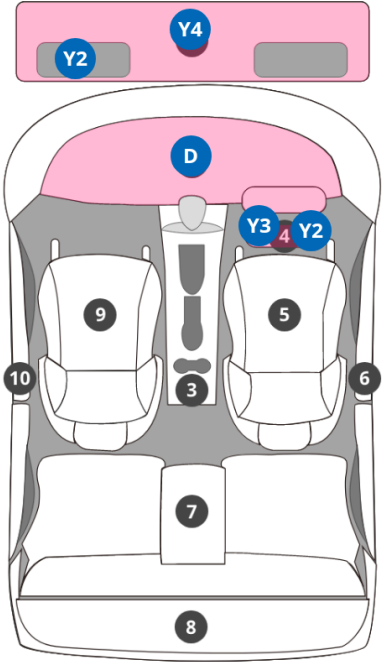
| Interior Evaluation : <span style="color: red; font-weight: bold;">C</span> | Exterior Evaluation : <span style="color: red; font-weight: bold;">E</span> |
|---|---|
| <b>Remarks</b><br>Ceiling - Grime - Large / (R) Front Floor Mat - Grime - Small / (L) Front Floor Mat - Grime - Medium / Dashboard - Traces of Adhesive Tape - Yes / Sunvisor, Sunglass Holder - Grime - Small | <b>Remarks</b><br>(R) Front Door - Repair Traces - Yes / (R) Step - Repair Traces - Yes / (R) Front Fender - Repair Traces - Yes / Bonnet - Repair Traces - Yes / (L) Front Fender - Repair Traces - Yes / (L) Front Door - Repair Traces - Yes / (L) Step - Repair Traces - Yes / (L) Rear Door - Repair Traces - Yes / (L) Rear Fender - Repair Traces - Yes / Trunk Hood, Rear Gate - Repair Traces - Yes / (R) Rear Fender - Repair Traces - Yes / (R) Rear Door - Repair Traces - Yes / Roof - Repair Traces - Yes / Front Windshield - Damaged - Large / (L) Mirror - Scratch - Small / Rear Bumper, Lamps, Panels - Scratch & Dent - Large / Rear Bumper, Lamps, Panels - Repair mark - Yes / (L) Rear Fender, Molding - Scratch - Medium / Trunk Hood, Rear Gate - Repair mark - Yes / (R) Rear Fender, Molding - Repair mark - Yes / (R) Rear Door, Molding - Repair mark - Yes / (R) Rear Door, Molding - Scratch - Large / (R) Rear Fender, Molding - Scratch - Medium / (R) Front Door, Molding - Scratch - Large / Roof - Dent - Small / (L) Rear Door, Molding - Scratch - Small / (L) Front Door, Molding - Scratch & Dent - Medium / (L) Front Fender, Molding - Scratch - Small / (R) Front Fender, Molding - Scratch & Dent - Small / Bonnet, Headlight - Scratch - Large / Front Bumper, Grille, Lamps - Repair mark - Yes / Front Bumper, Grille, Lamps - Scratch & Dent - Large / (R) Mirror - Crack - Damaged |

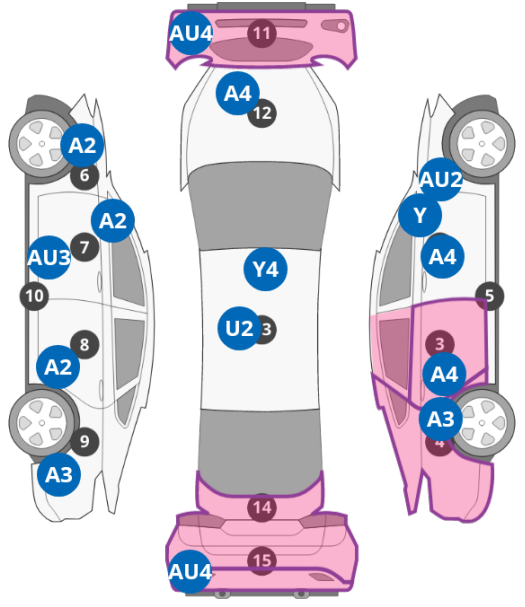
| Inspector Notes |
|---|
| Crack Windshield. Loose right side mirror. Without warranty booklet and tools. With spare tire, jack and leather seatcover. 1 key. With LTO plate |
