## General Information

| Make | Isuzu | Model | Traviz |
| Registration No. | CAW6278 | Chassis No. | MHCPHR54DMJ506720 |

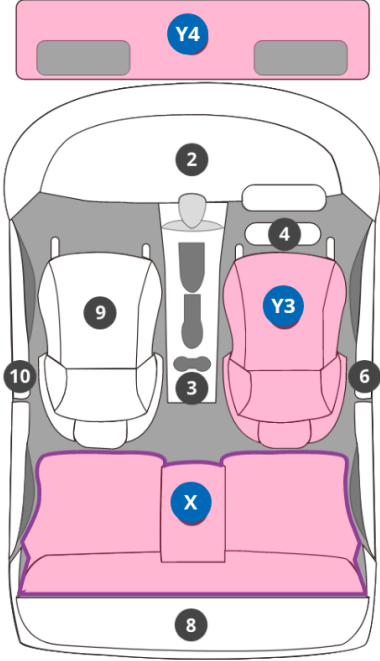
| Interior Evaluation : <span style="color: red;">C</span> | Exterior Evaluation : <span style="color: red;">D</span> |
| <p><b>Remarks</b></p> <p>Rear Seat - Partially Missing - Yes / (R) Front Seat - Grime - Medium / Ceiling - Grime - Large</p> | <p><b>Remarks</b></p> <p>(L) Rear Corner Panel - Repair Traces - Yes / (R) Side Gate - Scratch &amp; Dent - Large / Front Bumper, Grille, Lamps - Scratch - Large / (L) Front Door, Molding - Scratch - Small / (L) Mirror - Scratch - Small / (R) Mirror - Scratch - Small / (R) Front Door, Molding - Scratch &amp; Dent - Small / Rear Gate - Scratch &amp; Dent - Small / Rear Bumper, Lamps, Panels - Scratch &amp; Dent - Medium / Roof - Dent - Small / (L) Side Gate - Scratch &amp; Dent - Medium</p> |
