## General Information

| Make | Isuzu | Model | Traviz |
| Registration No. | NGB8183 | Chassis No. | MHCPHR54DLJ501852 |

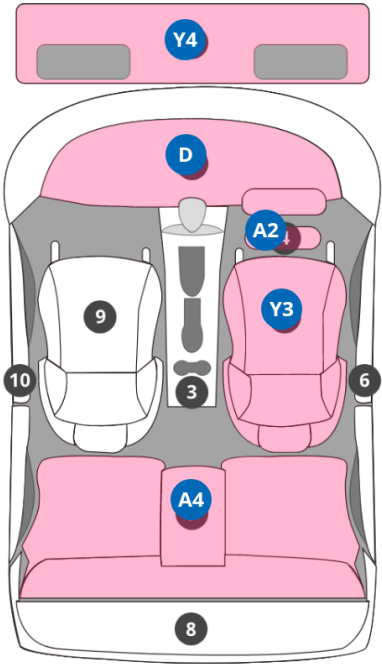
| <b>Remarks</b><br>Dashboard - Traces of Adhesive Tape - Yes / (R) Front Seat - Grime - Medium / Ceiling - Grime - Large / Rear Seat - Cut, Crack - Large / (L) Front Floor Mat - Cut, Crack - Small | <b>Remarks</b><br>(R) Side Gate - Scratch & Dent - Large / (L) Side Gate - Crack, Gap - Large / Rear Bumper, Lamps, Panels - Scratch & Dent - Large / Bonnet, Headlight - Scratch & Dent - Small / (L) Mirror - Scratch - Minimal / Roof - Dent - Large / (R) Front Door, Molding - Scratch - Medium / (L) Front Door, Molding - Scratch & Dent - Small / (L) Center Panel - Scratch - Small / Front Bumper, Grille, Lamps - Scratch - Medium / Front Windshield - Damaged - Large |

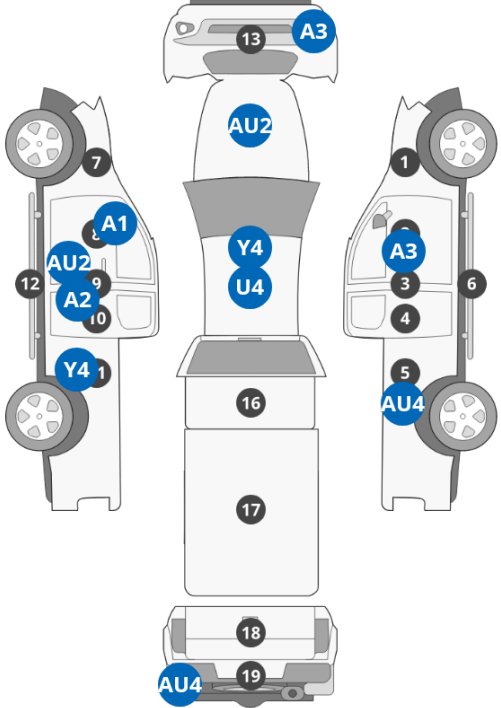
| Inspector Notes |
|---|
| Crack Windshield. Without warranty booklet and tools. With jack and spare tire. 2 keys. with LTO plate |
