## General Information

| Make | Toyota | Model | Vios |

## Body / Panel Condition

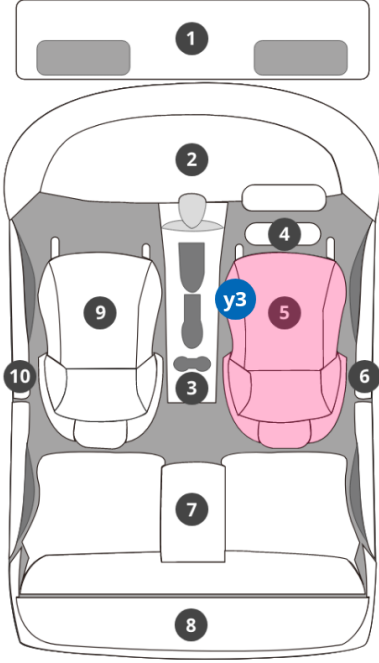
| Interior Evaluation : <b>B</b> | Exterior Evaluation : <b>C</b> |
| <b>Remarks</b><br>(R) Front Seat - Grime - Medium | <b>Remarks</b><br>(R) Front Fender, Molding - Scratch & Dent - Minimal / Front Bumper, Grille, Lamps - Scratch - Small / (R) Front Door, Molding - Scratch - Small / (R) Rear Fender, Molding - Dent - Minimal / Rear Bumper, Lamps, Panels - Scratch - Medium / (L) Front Door, Molding - Scratch - Large / (L) Rear Fender, Molding - Scratch - Minimal / (L) Rear Door, Molding - Scratch - Medium |

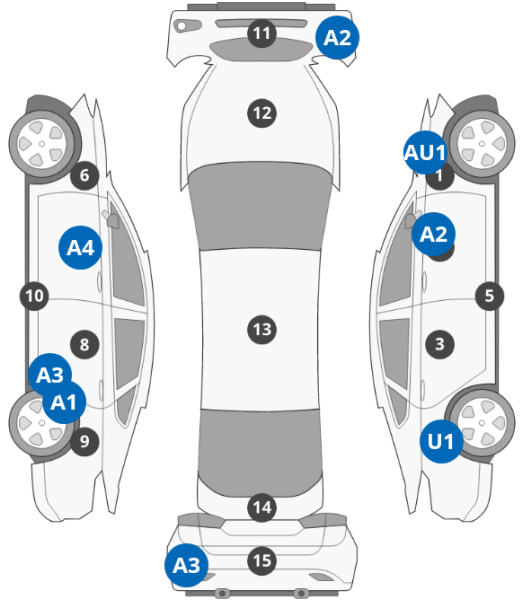
| Inspector Notes |
|---|
| hairline scratches around the exterior |
