## General Information

| Make | Toyota | Model | Vios |

## Body / Panel Condition

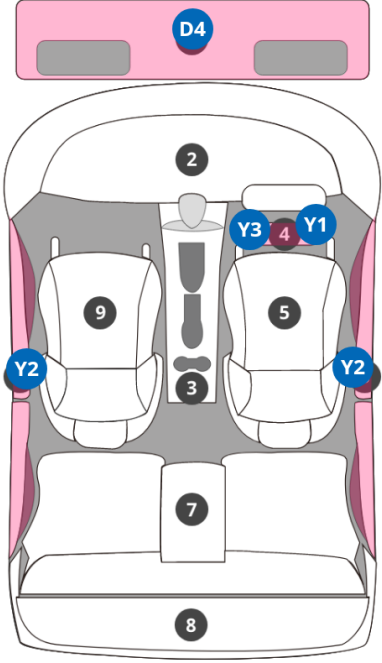
| <b>Interior Evaluation :</b> <span style="color: red; font-weight: bold;">C</span> | <b>Exterior Evaluation :</b> <span style="color: red; font-weight: bold;">C</span> |
| <b>Remarks</b><br>Ceiling - Crinkle - Large / (R) Front Trim - Grime - Small / (R) Front Floor Mat - Grime - Minimal / (L) Front Trim - Grime - Small / (L) Front Floor Mat - Grime - Medium | <b>Remarks</b><br>Roof - Scratch & Dent - Large / Front Windshield - Damaged - Large / Bonnet, Headlight - Scratch & Dent - Medium / (L) Front Fender, Molding - Scratch - Small / (L) Rear Fender, Molding - Scratch - Minimal / Trunk Hood, Rear Gate - Scratch - Minimal / (R) Rear Door, Molding - Scratch & Dent - Minimal / (R) Front Door, Molding - Scratch - Minimal / Front Bumper, Grille, Lamps - Scratch - Medium |

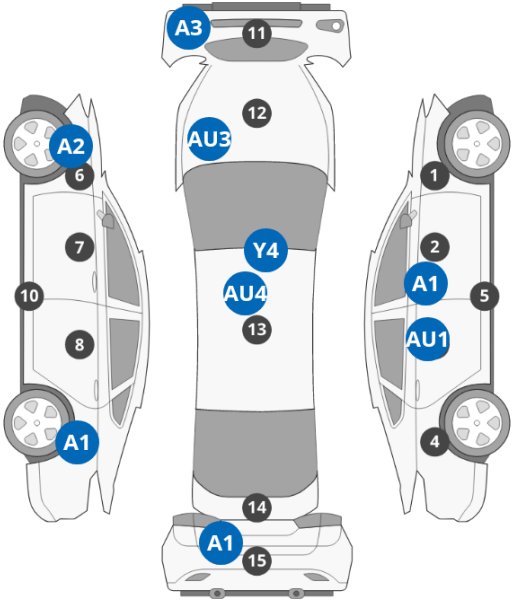
| Inspector Notes |
|---|
| Damaged front windshield. With warranty booklet, spare tire, jack, tools and seat cover. 3 keys. no LTO plate. |
