## General Information

| Make | Toyota | Model | Vios |

## Body / Panel Condition

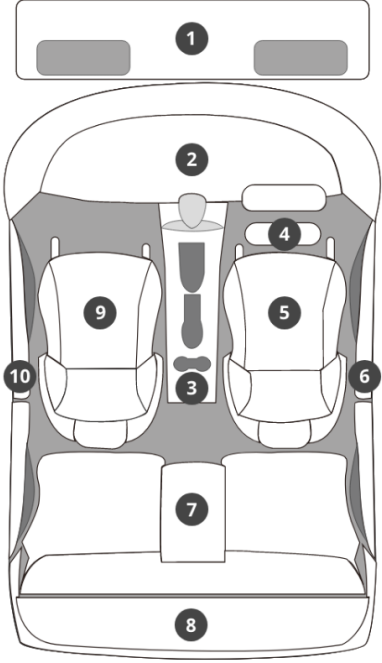
| <b>Interior Evaluation :</b> <span style="color: red; font-weight: bold;">A</span> | <b>Exterior Evaluation :</b> <span style="color: red; font-weight: bold;">B</span> |
| <b>Remarks</b><br>Defects not found | <b>Remarks</b><br>Rear Bumper, Lamps, Panels - Dent - Small / (R) Rear Door, Molding - Dent - Small / (R) Rear Fender, Molding - Dent - Small / (R) Front Door, Molding - Scratch - Minimal / (R) Front Fender, Molding - Scratch - Minimal / Front Bumper, Grille, Lamps - Scratch - Small / Bonnet, Headlight - Scratch - Minimal / (L) Front Fender, Molding - Scratch - Minimal / (L) Front Door, Molding - Scratch - Small / (L) Rear Door, Molding - Scratch & Dent - Small / (L) Rear Fender, Molding - Scratch - Minimal / Roof - Scratch - Minimal |

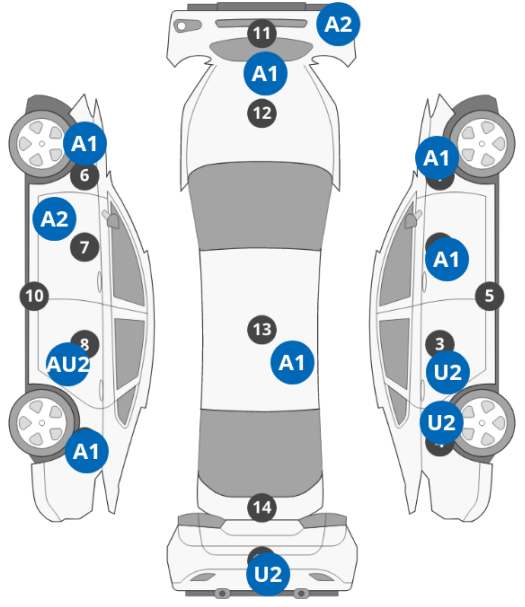
| Inspector Notes |
|---|
| no reverse camera/hairline around the vehicle//after market floor mats |
