## General Information

| Make | Toyota | Model | Veloz |
| Registration No. | CCD2626 | Chassis No. | MHFAB18YXR3094024 |

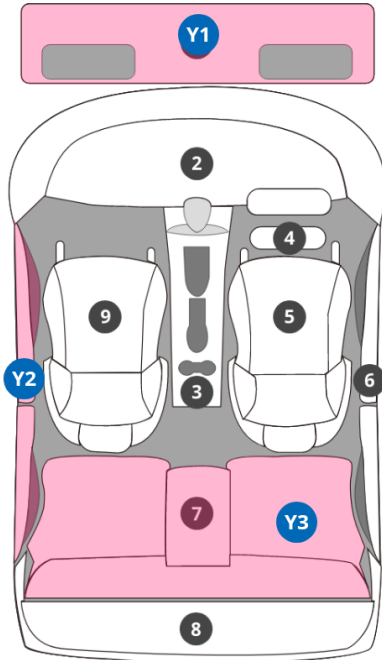
| <b>Remarks</b><br>Ceiling - Grime - Minimal / Rear Seat - Grime - Medium / (L) Front Trim - Grime - Small | <b>Remarks</b><br>(R) Mirror - Scratch - Minimal / (L) Front Door, Molding - Scratch - Minimal / (L) Rear Door, Molding - Scratch - Minimal / Front Bumper, Grille, Lamps - Scratch - Small / Rear Bumper, Lamps, Panels - Scratch - Small / (R) Rear Door, Molding - Scratch - Minimal / (R) Front Door, Molding - Scratch - Minimal / Roof - Scratch - Medium |
