## General Information

| Make | Toyota | Model | Avanza |

## Body / Panel Condition

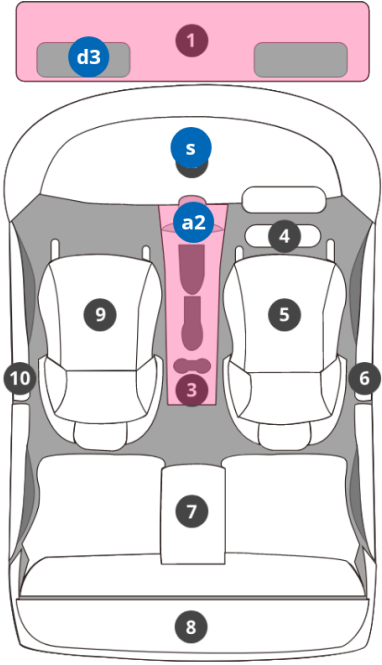
| <b>Interior Evaluation :</b> <span style="color: red; font-weight: bold;">B</span> | <b>Exterior Evaluation :</b> <span style="color: red; font-weight: bold;">C</span> |
| <b>Remarks</b><br>Sunvisor, Sunglass Holder - Crinkle - Medium / Console, Switches, Vents - Worn, Scratch, Cut, Crack - Small / Overall Interior - Smell - Yes | <b>Remarks</b><br>(R) Front Fender, Molding - Dent - Minimal / (R) Front Door, Molding - Scratch & Dent - Large / (R) Rear Fender, Molding - Dent - Minimal / (R) Rear Door, Molding - Scratch - Small / Rear Bumper, Lamps, Panels - Scratch & Dent - Small / (L) Front Door, Molding - Scratch - Medium / (L) Rear Fender, Molding - Scratch - Minimal / Front Bumper, Grille, Lamps - Scratch - Medium / Roof - Dent - Small |

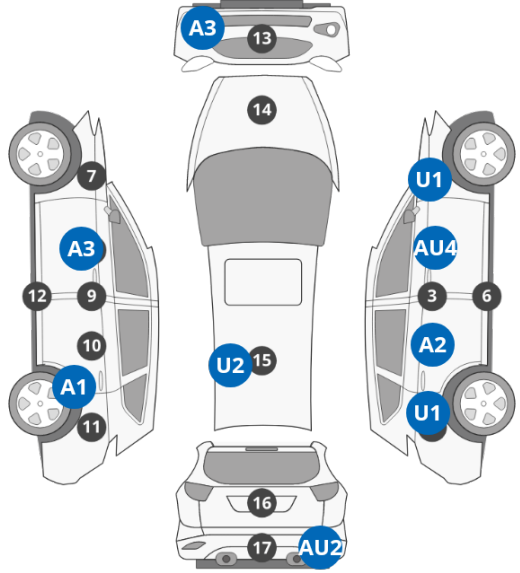
| Inspector Notes |
|---|
| light scratches around the exterior. dirty aftermarket mattings. |
