## General Information

| Make | Toyota | Model | Vios |
| YOM | 2021 | Odo Meter Reading | 28,331 |
| Registration No. | NEO2186 | Chassis No. | PA1B18F38M4153721 |

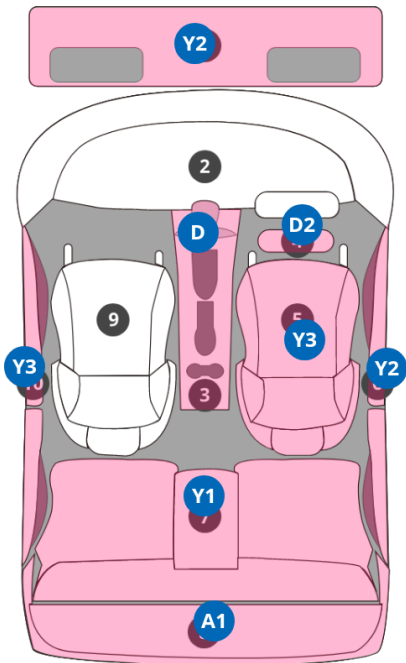
| Interior Evaluation : <b>C</b> | Exterior Evaluation : <b>B</b> |
| <p><b>Remarks</b></p> <p>Trunk Room - Worn, Scratch, Cut, Crack - Minimal / Rear Seat - Grime - Minimal / (R) Front Seat - Grime - Medium / (R) Front Trim - Grime - Small / (L) Front Trim - Grime - Medium / (L) Front Floor Mat - Worked - Small / Ceiling - Grime - Small / Overall Interior - Worn as per age - Yes / Console, Switchs, Vents - Traces of Adhesive Tape - Yes</p> | <p><b>Remarks</b></p> <p>(R) Mirror - Scratch - Small / (R) Rear Door, Molding - Scratch &amp; Dent - Minimal / (R) Front Door, Molding - Scratch - Minimal / (R) Rear Fender, Molding - Scratch - Minimal / Rear Bumper, Lamps, Panels - Scratch - Small / Trunk Hood, Rear Gate - Dent - Small / (L) Rear Door, Molding - Scratch - Minimal / (L) Rear Fender, Molding - Scratch &amp; Dent - Small / Roof - Scratch - Minimal / (L) Front Door, Molding - Scratch - Minimal / (L) Front Fender, Molding - Scratch - Small / Member (Bolted) - Dent - Yes / Front Bumper, Grille, Lamps - Scratch - Small / Bonnet, Headlight - Scratch &amp; Dent - Minimal</p> |
