## General Information

| Make | Toyota | Model | Vios |
| YOM | 2023 | Odo Meter Reading | 103,793 |

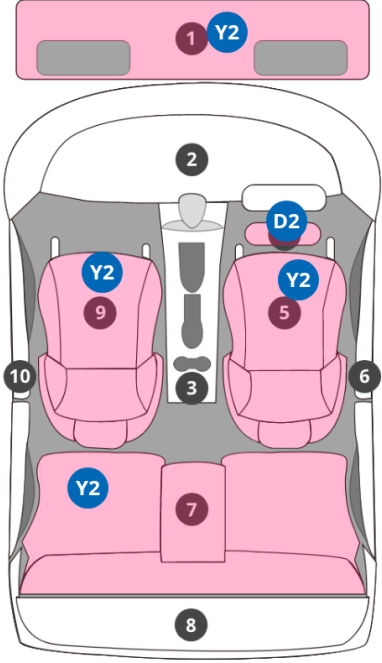
| <b>Interior Evaluation :</b> <span style="color: red; font-weight: bold;">B</span> | <b>Exterior Evaluation :</b> <span style="color: red; font-weight: bold;">C</span> |
| <b>Remarks</b><br>Ceiling - Grime - Small / (L) Front Seat - Grime - Small / (R) Front Seat - Grime - Small / Rear Seat - Grime - Small / (L) Front Floor Mat - Worked - Small | <b>Remarks</b><br>(L) Rear Door - Repair Traces - Yes / Member (Bolted) - Dent - Yes / (R) Front Fender, Molding - Scratch - Medium / (R) Front Door, Molding - Scratch - Minimal / (R) Rear Door, Molding - Scratch & Dent - Small / (R) Rear Fender, Molding - Scratch & Dent - Small / Rear Bumper, Lamps, Panels - Scratch & Dent - Small / Trunk Hood, Rear Gate - Scratch & Dent - Small / (L) Rear Fender, Molding - Scratch - Small / (L) Rear Door, Molding - Scratch - Small / (L) Front Door, Molding - Scratch - Small / (L) Front Fender, Molding - Scratch - Medium / Front Bumper, Grille, Lamps - Scratch - Medium |

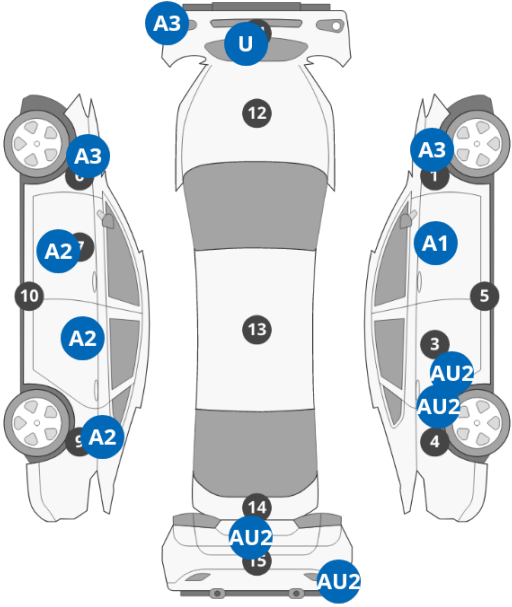
| with LTO plate and Jack, Sparetire and incomplete tools. no warranty booklet, crack tail light and scratch headlight. |
