## General Information

| Make | Toyota | Model | Vios |
| YOM | 2023 | Odo Meter Reading | 45,837 |

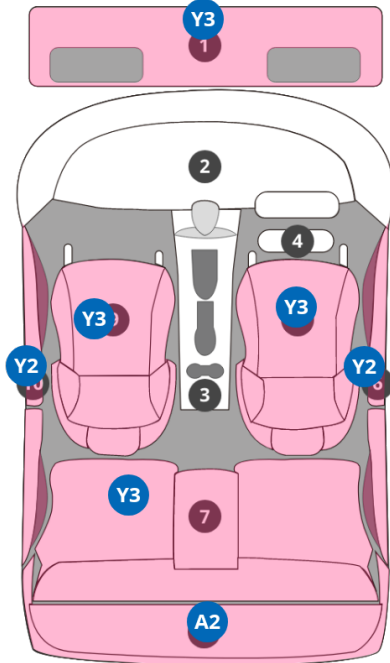
| <b>Interior Evaluation :</b> <span style="color: red; font-weight: bold;">C</span> | <b>Exterior Evaluation :</b> <span style="color: red; font-weight: bold;">C</span> |
| <b>Remarks</b><br>Trunk Room - Worn, Scratch, Cut, Crack - Small / Rear Seat - Grime - Medium / (R) Front Seat - Grime - Medium / Ceiling - Grime - Medium / (R) Front Trim - Grime - Small / (L) Front Seat - Grime - Medium / (L) Front Trim - Grime - Small | <b>Remarks</b><br>(R) Front Fender, Molding - Scratch - Small / (R) Front Door, Molding - Scratch - Small / (R) Rear Door, Molding - Dent - Medium / (R) Step, In-panel, Side Spoiler - Dent - Small / (R) Rear Fender, Molding - Scratch - Small / Rear Bumper, Lamps, Panels - Scratch - Small / Trunk Hood, Rear Gate - Scratch - Small / (L) Rear Fender, Molding - Scratch - Minimal / (L) Rear Door, Molding - Scratch - Small / (L) Front Door, Molding - Scratch - Small / (L) Front Fender, Molding - Scratch - Small / Front Bumper, Grille, Lamps - Scratch - Small / Roof - Scratch - Small / Bonnet, Headlight - Scratch - Small |
