## General Information

| Make | Toyota | Model | Vios |

## Body / Panel Condition

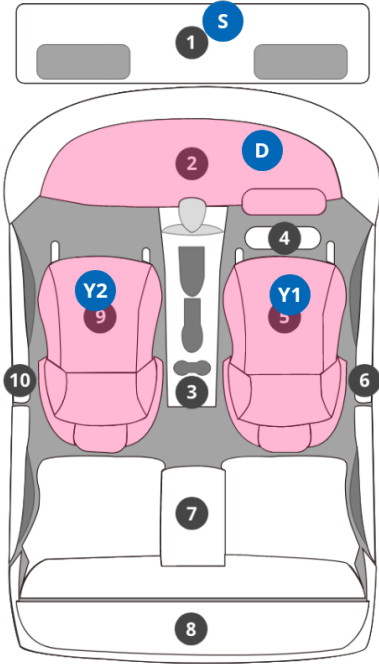
| Interior Evaluation : <b>B</b> | Exterior Evaluation : <b>C</b> |
| <p><b>Remarks</b><br/>(R) Front Seat - Grime - Minimal / (L) Front Seat - Grime - Small / Dashboard - Traces of Adhesive Tape - Yes / Overall Interior - Smell - Yes</p> | <p><b>Remarks</b><br/>(R) Front Fender, Molding - Scratch &amp; Dent - Medium / (R) Step, In-panel, Side Spoiler - Scratch - Small / (R) Front Door, Molding - Scratch - Minimal / (R) Rear Door, Molding - Scratch - Small / (R) Rear Fender, Molding - Scratch &amp; Dent - Small / Trunk Hood, Rear Gate - Scratch - Small / (L) Rear Door, Molding - Scratch - Small / (L) Rear Fender, Molding - Scratch - Minimal / (L) Front Door, Molding - Scratch - Minimal / (L) Front Fender, Molding - Scratch - Small / Front Bumper, Grille, Lamps - Crack, Gap - Small / Bonnet, Headlight - Scratch - Small / Roof - Scratch - Small / Rear Bumper, Lamps, Panels - Scratch - Small</p> |

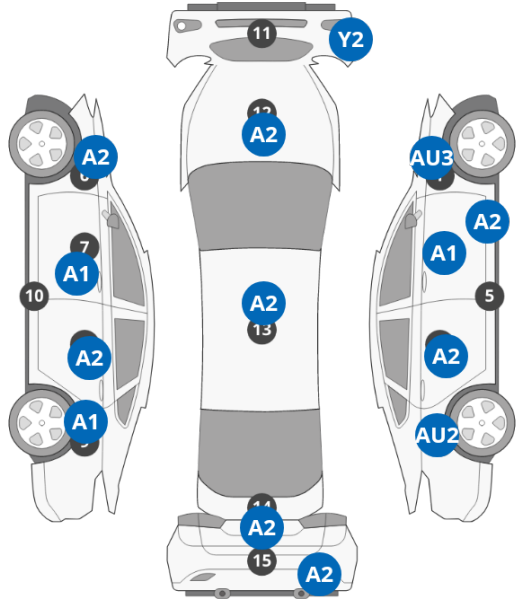
| Inspector Notes |
|---|
| with warranty booklet and LTO plate, Jack and sparetire and incomplete tools. partially missing front bumper. tow hook cover, scratch headlight and tail light. |
