General Information

Date & Time: 18, Jun, 2025 11:00

Make	Lexus	Model	RX350
YOM	2017	Odo Meter Reading	100,687
Registration No.	NAC8869	Chassis No.	JTJZZMCA4G2001088
CC	3.5	Transmission	A/T
Fuel Type	Gas	Type of Body	SUV
Colour	Gray

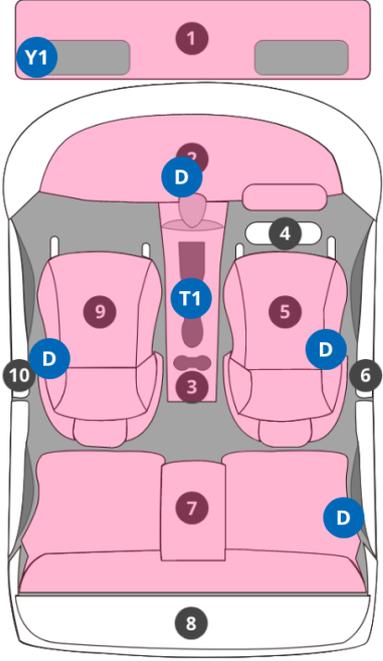
<p>a : Cut, Fray d : Loose, Deformed k : Animal Hair s : Smell t : Cigarette Burns x : Defective y : Stain</p>

<p>A : Scratch AU : Scratch & Dent B : Modified C : Corrosion G : Stone chip P : Faded S : Rust SC : Rust & Corrosion U : Dent X : Defective Y : Crack, Gap</p>
<p>Remarks Rear Seat - Worn - Yes / (R) Front Seat - Worn - Yes / (L) Front Seat - Worn - Yes / Console, Switchs, Vents - Cigarette Burns - Burnt Minimal / Dashboard - Traces of Adhesive Tape - Yes / Ceiling - Grime - Minimal</p>	<p>Remarks Trunk Hood, Rear Gate - Repair Traces - Yes / (R) Front Fender, Molding - Scratch & Dent - Small / (R) Rear Door, Molding - Scratch - Minimal / Rear Bumper, Lamps, Panels - Crack, Gap - Medium / Trunk Hood, Rear Gate - Crack, Gap - Small / Bonnet, Headlight - Scratch - Small / Front Bumper, Grille, Lamps - Scratch & Dent - Small / (L) Front Fender, Molding - Scratch - Minimal / (L) Front Door, Molding - Scratch & Dent - Minimal / Front Windshield - Damaged - Large</p>

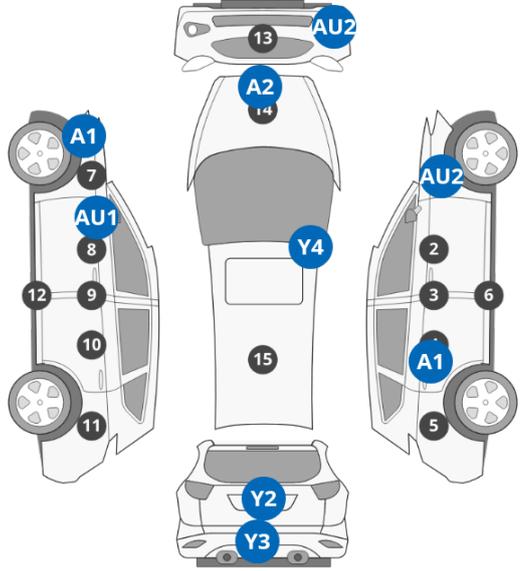
<p>Inspector Notes</p>
<p>with warranty booklet, with jack and tools, with spare tire, with LTO plate, weak battery, warning lamps on, air-conditioning system issue (only heater working), remote key issue, crack on front windshield, rear emblem crack</p>
