General Information

Make	Toyota	Model	Vios
YOM	2023	Odo Meter Reading	47,617
Registration No.	NFC8385	Chassis No.	PA1B18F35P4222577
CC	1.3	Transmission	CVT
Fuel Type	Gas	Type of Body	Sedan
Colour	Blue

Body / Panel Condition

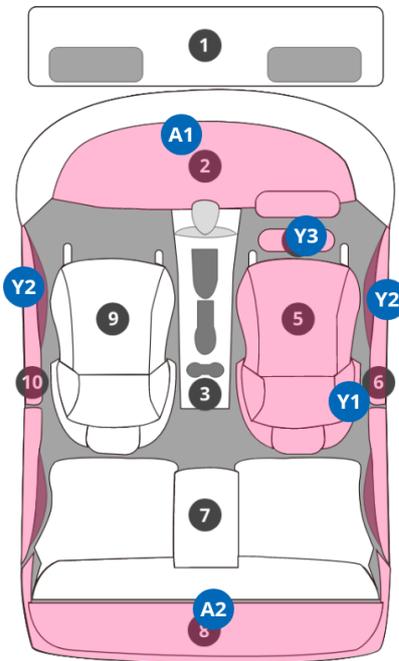
<p>a : Cut, Fray d : Loose, Deformed k : Animal Hair s : Smell t : Cigarette Burns x : Defective y : Stain</p>

<p>A : Scratch AU : Scratch & Dent B : Modified C : Corrosion G : Stone chip P : Faded S : Rust SC : Rust & Corrosion U : Dent X : Defective Y : Crack, Gap</p>
<p>Remarks (L) Front Floor Mat - Grime - Medium / (R) Front Seat - Grime - Minimal / Dashboard - Worn, Scratch, Cut, Crack - Minimal / Trunk Room - Worn, Scratch, Cut, Crack - Small / (L) Front Trim - Grime - Small / (R) Front Trim - Grime - Small</p>	<p>Remarks Rear Bumper, Lamps, Panels - Scratch - Medium / Trunk Hood, Rear Gate - Scratch - Minimal / (L) Mirror - Scratch - Minimal / Front Bumper, Grille, Lamps - Scratch - Medium / (R) Front Door, Molding - Scratch - Minimal / (R) Step, In-panel, Side Spoiler - Scratch & Dent - Medium / (R) Rear Fender, Molding - Scratch & Dent - Minimal / Roof - Scratch - Minimal / (L) Rear Door, Molding - Scratch - Minimal / (L) Rear Fender, Molding - Scratch - Minimal</p>
