## General Information

| Make | Toyota | Model | Raize |
| YOM | 2023 | Mileage | 34,907 |
| Registration No. | DBB6053 | Chassis No. | MHKAA1BA2PJ081736 |

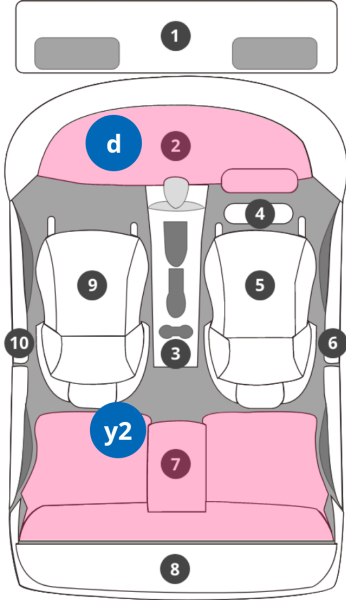
| Interior Evaluation : <span style="color: red; font-weight: bold;">A</span> | Exterior Evaluation : <span style="color: red; font-weight: bold;">B</span> |
| <b>Remarks</b><br>Dashboard - Traces of Adhesive Tape - Yes / Rear Seat - Grime - Small | <b>Remarks</b><br>(L) Mirror - Scratch - Small / Rear Bumper, Lamps, Panels - Dent - Small / Front Bumper, Grille, Lamps - Scratch - Medium |

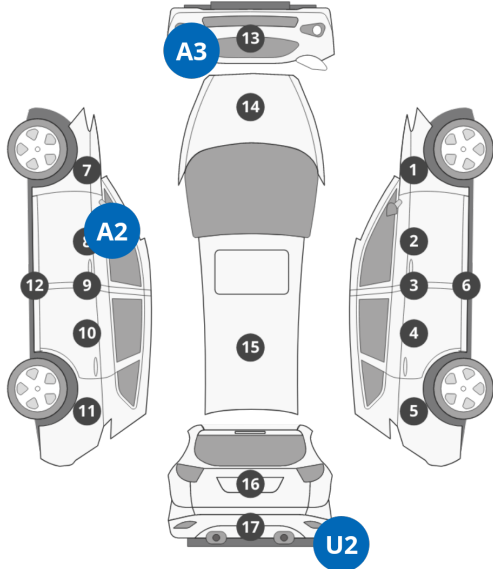
hairline scratches and swirl marks/ aftermarket floor mats/
