## General Information

| Make | Suzuki | Model | Carry |
| YOM | 2024 | Odo Meter Reading | 19,224 |
| Registration No. | NKB6866 | Chassis No. | MHYDC61T3RJ211992 |

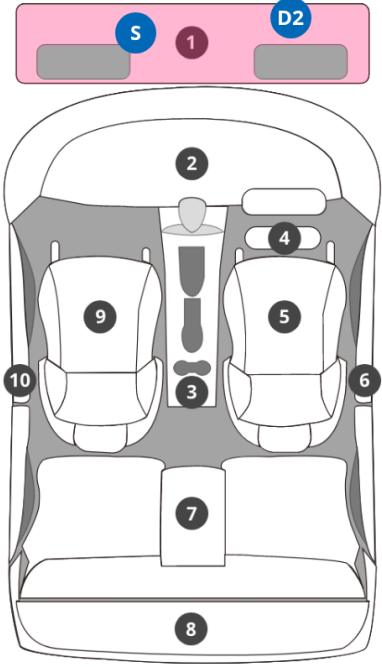
| Interior Evaluation : <b>B</b> | Exterior Evaluation : <b>C</b> |
| <b>Remarks</b><br>Ceiling - Crinkle - Small / Overall Interior - Smell - Yes | <b>Remarks</b><br>(L) Rear Corner Panel - Repair Traces - Yes / (R) Rear Corner Panel - Repair Traces - Yes / (L) Side Gate - Scratch - Medium / Rear Gate - Scratch - Small / Rear Bumper, Lamps, Panels - Scratch - Small / (R) Side Gate - Scratch - Small / (R) Front Door, Molding - Scratch - Small / Front Bumper, Grille, Lamps - Scratch - Small / Roof - Scratch - Small / (L) Front Door, Molding - Scratch - Small / (L) Front Fender, Molding - Scratch - Minimal / (R) Front Fender, Molding - Scratch - Small / Front Panel - Scratch - Small |

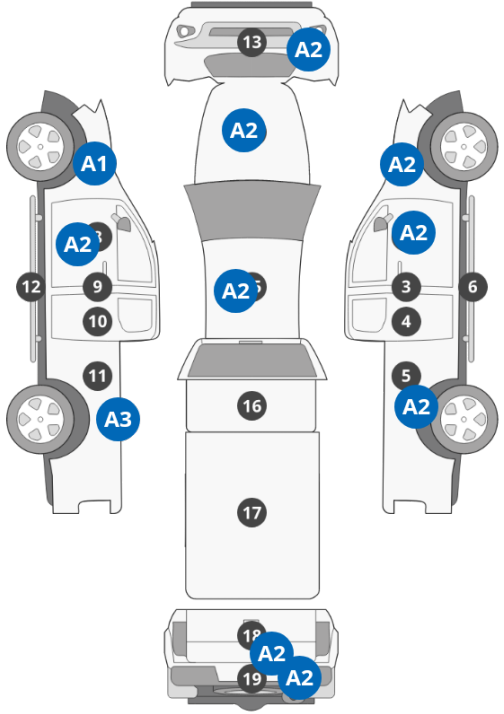
| Inspector Notes |
|---|
| with spare tire. no warranty booklet and LTO plate, Jack and tools. scratch tail light and headlight. |
