## General Information

| Make | Suzuki | Model | Carry |
| YOM | 2024 | Odo Meter Reading | 5,627 |
| Registration No. | NKE7292 | Chassis No. | MHYDC61T8SJ210746 |

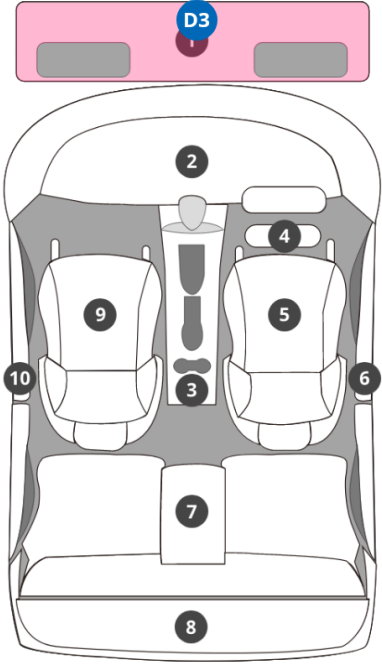
| Interior Evaluation : <b>B</b> | Exterior Evaluation : <b>C</b> |
|---|---|
| <b>Remarks</b><br>Ceiling - Loose, Deformed - Medium | <b>Remarks</b><br>(R) Front Fender, Molding - Scratch - Minimal / (R) Front Door, Molding - Scratch - Small / (R) Center Panel - Dent - Minimal / (R) Rear Door, Molding - Scratch - Minimal / (R) Side Gate - Scratch - Small / Roof - Scratch - Small / Cargo Bed Floor - Scratch - Medium / Rear Gate - Scratch - Minimal / Rear Bumper, Lamps, Panels - Scratch - Small / (L) Side Gate - Scratch - Small / (L) Rear Door, Molding - Scratch - Minimal / (L) Center Panel - Scratch - Minimal / (L) Front Door, Molding - Scratch - Small / Front Bumper, Grille, Lamps - Scratch - Small / Front Panel - Scratch - Small |
