## General Information

| Make | Toyota | Model | Yaris Cross |
| Registration No. | CCA3445 | Chassis No. | MHFAABAF1P0005791 |

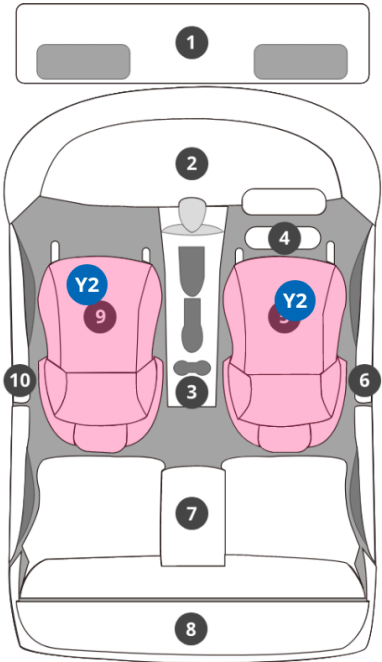
| <b>Remarks</b><br>(R) Front Seat - Grime - Small / (L) Front Seat - Grime - Small | <b>Remarks</b><br>(L) Front Door, Molding - Scratch & Dent - Large / (L) Front Fender, Molding - Scratch & Dent - Medium / Front Bumper, Grille, Lamps - Scratch - Large / (R) Front Door, Molding - Dent - Minimal / (R) Rear Door, Molding - Scratch - Small / (R) Rear Fender, Molding - Scratch - Minimal / Rear Bumper, Lamps, Panels - Scratch - Small / (L) Rear Door, Molding - Scratch & Dent - Minimal / Trunk Hood, Rear Gate - Scratch - Minimal / Bonnet, Headlight - Scratch - Small / (L) Rear Fender, Molding - Scratch - Minimal |

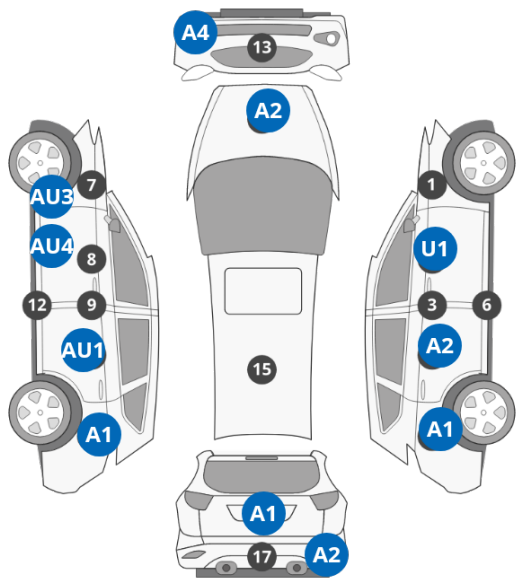
| Inspector Notes |
|---|
| With LTO plate. no Tools and jack, Sparetire and warranty booklet. scratch headlight and tail light. |
