## General Information

| Make | Toyota | Model | Vios |
| YOM | 2024 | Odo Meter Reading | 28,810 |
| Registration No. | DBJ9197 | Chassis No. | PA1B18F3XP4227578 |

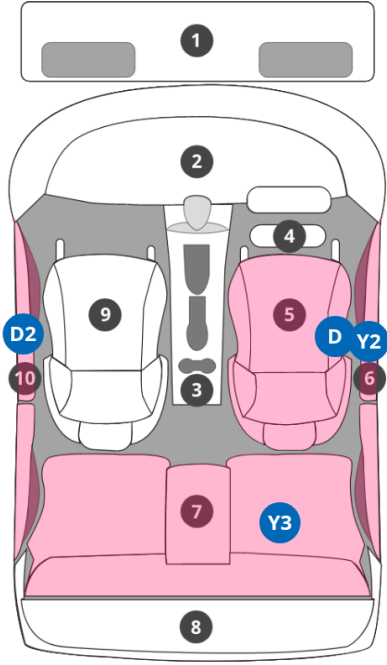
| Interior Evaluation : <b>B</b> | Exterior Evaluation : <b>B</b> |
| <p><b>Remarks</b><br/>Rear Seat - Grime - Medium / (R) Front Trim - Grime - Small / (R) Front Seat - Worn - Yes / (L) Front Trim - Worked - Small</p> | <p><b>Remarks</b><br/>(R) Rear Door, Molding - Scratch - Small / Rear Bumper, Lamps, Panels - Scratch - Minimal / Trunk Hood, Rear Gate - Scratch &amp; Dent - Small / (L) Rear Door, Molding - Scratch - Small / (L) Rear Fender, Molding - Scratch - Minimal / (L) Front Door, Molding - Scratch - Minimal / Member (Bolted) - Dent - Yes / Front Bumper, Grille, Lamps - Scratch - Medium / (R) Front Fender, Molding - Repair mark - Yes</p> |
