## General Information

| Make | Mitsubishi | Model | Mirage |
| Registration No. | NIF7957 | Chassis No. | PAEA13TJPNA002698 |

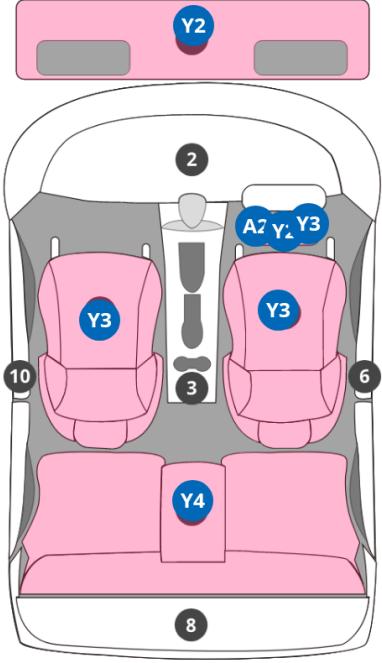
| Interior Evaluation : <b>C</b> | Exterior Evaluation : <b>E</b> |
| <p><b>Remarks</b><br/>Ceiling - Grime - Small / (L) Front Seat - Grime - Medium / (R) Front Seat - Grime - Medium / Rear Seat - Grime - Large / (L) Front Floor Mat - Cut, Crack - Small / Mat Other - Grime - Small / (R) Front Floor Mat - Grime - Medium</p> | <p><b>Remarks</b><br/>(R) Rear Door - Repair Traces - Yes / (L) Mirror - Scratch - Minimal / Front Bumper, Grille, Lamps - Scratch - Large / Bonnet, Headlight - Scratch - Small / (R) Front Fender, Molding - Dent - Small / (R) Mirror - Scratch - Small / (R) Front Door, Molding - Scratch - Minimal / (R) Rear Door, Molding - Scratch - Medium / (R) Rear Fender, Molding - Scratch &amp; Dent - Large / Rear Bumper, Lamps, Panels - Scratch &amp; Dent - Large / Trunk Hood, Rear Gate - Scratch - Medium / (L) Rear Fender, Molding - Scratch - Small / (L) Rear Door, Molding - Scratch - Minimal / (L) Front Door, Molding - Scratch - Small / (L) Front Fender, Molding - Dent - Small / Roof - Dent - Small</p> |
