## General Information

| Make | Toyota | Model | Wigo |
| Registration No. | CBM4039 | Chassis No. | MHKA4DF5FMJ054643 |

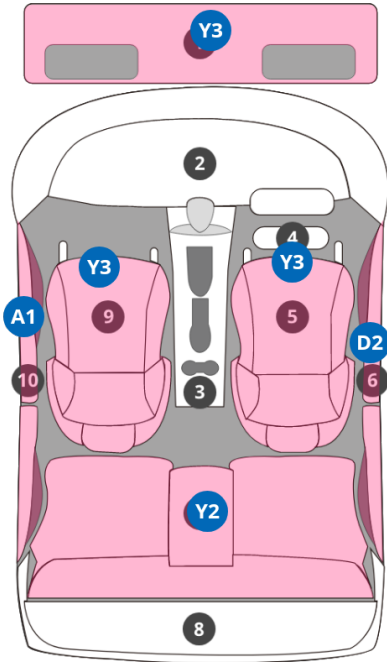
| Interior Evaluation : <b>B</b> | Exterior Evaluation : <b>E</b> |
| <b>Remarks</b><br>Rear Seat - Grime - Small / (R) Front Seat - Grime - Medium / (R) Front Trim - Worked - Small / (L) Front Trim - Cut, Crack - Minimal / Ceiling - Grime - Medium / (L) Front Seat - Grime - Medium | <b>Remarks</b><br>(R) Front Fender, Molding - Scratch & Dent - Small / (R) Mirror - Scratch - Small / (R) Front Door, Molding - Scratch - Medium / (R) Step, In-panel, Side Spoiler - Scratch - Small / (R) Rear Door, Molding - Scratch - Medium / (R) Rear Fender, Molding - Scratch - Minimal / Rear Bumper, Lamps, Panels - Scratch - Medium / (L) Front Door, Molding - Scratch - Small / (L) Step, In-panel, Side Spoiler - Scratch - Small / (L) Rear Door, Molding - Scratch - Minimal / (L) Rear Fender, Molding - Scratch - Minimal / (L) Front Fender, Molding - Scratch - Small / Front Bumper, Grille, Lamps - Scratch - Large / Bonnet, Headlight - Scratch - Medium / Roof - Rust, Corrosion - Large |

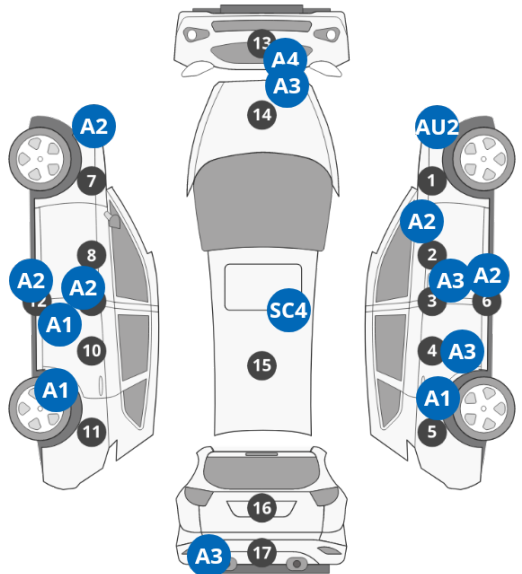
with warranty booklet, with jack, no tools, with spare tire, with LTO plate, scratches on headlight, suncrack tail light, trunk room partially missing
