## General Information

| Make | Toyota | Model | Vios |

## Body / Panel Condition

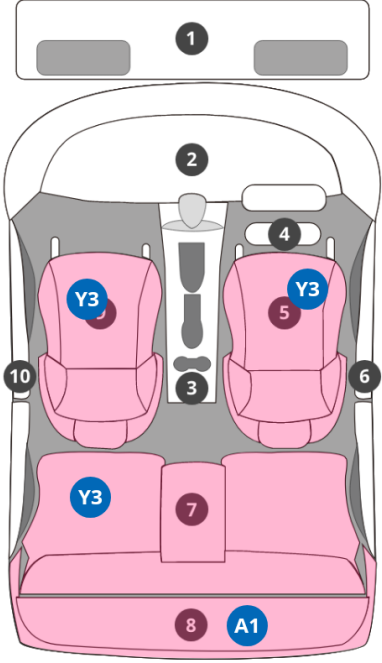
| <b>Interior Evaluation :</b> <b>B</b> | <b>Exterior Evaluation :</b> <b>C</b> |
| <b>Remarks</b><br>Trunk Room - Worn, Scratch, Cut, Crack - Minimal /<br>Rear Seat - Grime - Medium / (R) Front Seat - Grime -<br>Medium / (L) Front Seat - Grime - Medium | <b>Remarks</b><br>(R) Front Fender, Molding - Scratch - Minimal / (R) Front Door,<br>Molding - Scratch - Minimal / (R) Rear Door, Molding - Scratch &<br>Dent - Small / (R) Rear Fender, Molding - Scratch - Minimal / Rear<br>Bumper, Lamps, Panels - Scratch - Medium / Trunk Hood, Rear Gate -<br>Scratch - Small / (L) Rear Fender, Molding - Scratch - Small / (L) Rear<br>Door, Molding - Scratch & Dent - Small / (L) Front Door, Molding -<br>Scratch - Small / (L) Front Fender, Molding - Scratch & Dent - Small /<br>Front Bumper, Grille, Lamps - Repair mark - Yes / Front Bumper,<br>Grille, Lamps - Scratch - Small / Roof - Scratch - Minimal / Bonnet,<br>Headlight - Scratch - Minimal |
