## General Information

| Make | Toyota | Model | Vios |
| YOM | 2022 | Odo Meter Reading | 67,719 |
| Registration No. | DAQ5334 | Chassis No. | PA1B18F37N4175646 |

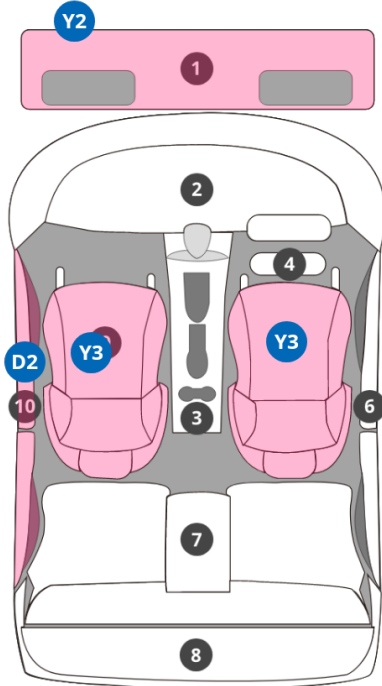
| Interior Evaluation : <b>B</b> | Exterior Evaluation : <b>C</b> |
|---|---|
| <p><b>a</b> : Cut, Fray <b>d</b> : Loose, Deformed <b>k</b> : Animal Hair <b>s</b> : Smell <b>t</b> : Cigarette Burns <b>x</b> : Defective <b>y</b> : Stain</p> | <p><b>A</b> : Scratch <b>AU</b> : Scratch &amp; Dent <b>B</b> : Modified <b>C</b> : Corrosion <b>G</b> : Stone chip <b>P</b> : Faded <b>S</b> : Rust <b>SC</b> : Rust &amp; Corrosion <b>U</b> : Dent <b>X</b> : Defective <b>Y</b> : Crack, Gap</p> |
| <p><b>Remarks</b><br/>(R) Front Seat - Grime - Medium / (L) Front Seat - Grime - Medium / (L) Front Trim - Worked - Small / Ceiling - Grime - Small</p> | <p><b>Remarks</b><br/>(R) Front Fender, Molding - Scratch - Medium / (R) Front Door, Molding - Scratch - Minimal / (R) Rear Door, Molding - Scratch - Small / (R) Rear Fender, Molding - Scratch - Small / Rear Bumper, Lamps, Panels - Scratch - Medium / Trunk Hood, Rear Gate - Crack, Gap - Small / (L) Rear Fender, Molding - Scratch - Small / (L) Front Door, Molding - Scratch - Minimal / (L) Mirror - Scratch - Minimal / Member (Bolted) - Dent - Yes / Front Bumper, Grille, Lamps - Crack, Gap - Large / Bonnet, Headlight - Scratch - Minimal / Roof - Scratch &amp; Dent - Small</p> |
