## General Information

| Make | Toyota | Model | Wigo |
| YOM | 2022 | Odo Meter Reading | 23,988 |
| Registration No. | NHB2281 | Chassis No. | MHKA4DE5FNJ017413 |

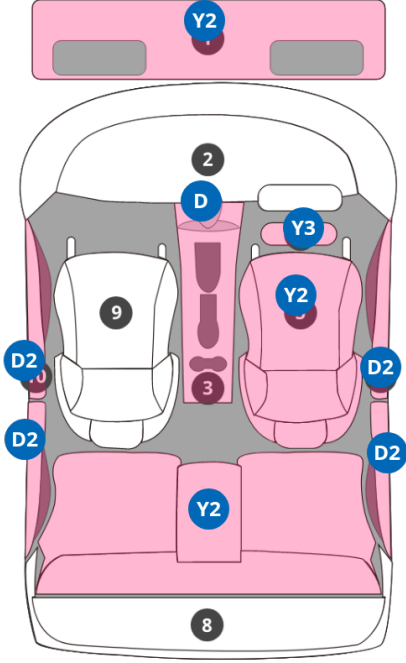
| <b>Remarks</b><br>(R) Front Floor Mat - Grime - Medium / (R) Front Seat - Grime - Small / Rear Seat - Grime - Small / Ceiling - Grime - Small / (L) Rear Trim - Worked - Small / (R) Rear Trim - Worked - Small / (L) Front Trim - Worked - Small / (R) Front Trim - Worked - Small / Console, Switches, Vents - Traces of Adhesive Tape - Yes | <b>Remarks</b><br>(R) Front Fender - Repair Traces - Yes / (L) Front Fender - Repair Traces - Yes / (L) Front Door - Repair Traces - Yes / (R) Front Fender, Molding - Scratch - Minimal / (R) Mirror - Scratch - Small / (R) Front Door, Molding - Scratch - Minimal / (R) Rear Door, Molding - Scratch - Small / (R) Rear Fender, Molding - Scratch & Dent - Small / (R) Rear Fender, Molding - Repair mark - Yes / Rear Bumper, Lamps, Panels - Repair mark - Yes / (R) Front Fender, Molding - Repair mark - Yes / Rear Bumper, Lamps, Panels - Scratch - Small / Trunk Hood, Rear Gate - Scratch - Minimal / (L) Rear Fender, Molding - Scratch & Dent - Small / (L) Rear Door, Molding - Scratch - Small / (L) Front Door, Molding - Scratch - Medium / (L) Mirror - Scratch - Minimal / (L) Front Fender, Molding - Scratch - Minimal / Roof - Scratch - Minimal / Front Bumper, Grille, Lamps - Repair mark - Yes / Front Bumper, Grille, Lamps - Scratch - Small / Bonnet, Headlight - Scratch - Minimal |
