## General Information

| Make | Toyota | Model | Vios |

## Body / Panel Condition

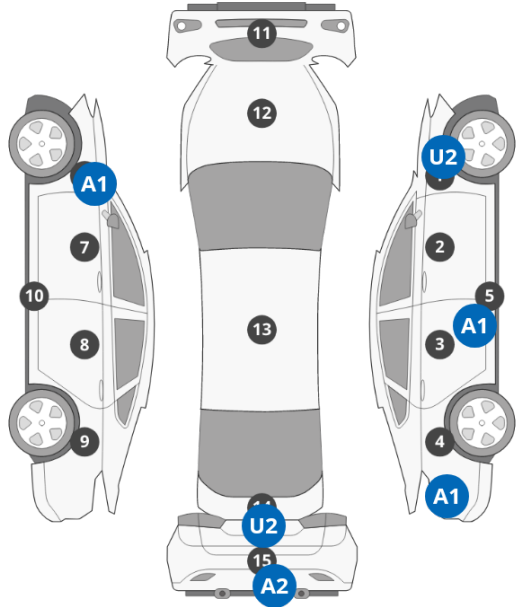
| Interior Evaluation : <span style="color: red; font-weight: bold;">A</span> | Exterior Evaluation : <span style="color: red; font-weight: bold;">A</span> |
|---|---|
| <b>Remarks</b><br>Defects not found | <b>Remarks</b><br>(L) Rear Fender - Repair Traces - Yes / (R) Front Fender, Molding - Dent - Small / (R) Rear Door, Molding - Scratch - Minimal / (R) Rear Fender, Molding - Scratch - Minimal / Trunk Hood, Rear Gate - Dent - Small / Rear Bumper, Lamps, Panels - Scratch - Small / (L) Front Fender, Molding - Scratch - Minimal |

| Inspector Notes |
|---|
| hairlines scratch & swirl marks door ding protection |
