## General Information

| Make | Toyota | Model | Vios |
| Registration No. | NHJ6567 | Chassis No. | PA1B18F36P4219283 |

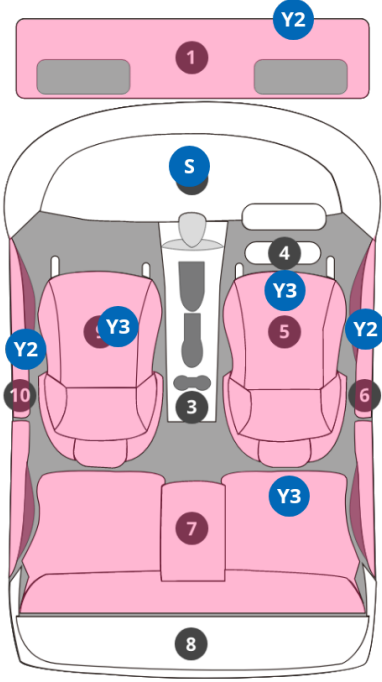
| <b>Interior Evaluation :</b> <span style="color: red; font-weight: bold;">B</span> | <b>Exterior Evaluation :</b> <span style="color: red; font-weight: bold;">D</span> |
| <b>Remarks</b><br>(R) Front Seat - Grime - Medium / (L) Front Seat - Grime - Medium / Rear Seat - Grime - Medium / Overall Interior - Smell - Yes / (R) Front Trim - Grime - Small / (L) Front Trim - Grime - Small / Ceiling - Grime - Small | <b>Remarks</b><br>(L) Front Door - Repair Traces - Yes / Front Bumper, Grille, Lamps - Repair mark - Yes / (R) Front Fender, Molding - Scratch - Small / (R) Step, In-panel, Side Spoiler - Dent - Medium / (R) Front Door, Molding - Scratch - Small / (R) Rear Door, Molding - Scratch - Small / (R) Rear Fender, Molding - Scratch - Minimal / Rear Bumper, Lamps, Panels - Scratch - Small / (L) Rear Fender, Molding - Scratch & Dent - Small / (L) Rear Door, Molding - Scratch & Dent - Large / (L) Front Door, Molding - Scratch - Small / (L) Mirror - Scratch - Minimal / (L) Front Fender, Molding - Scratch & Dent - Minimal / Front Bumper, Grille, Lamps - Scratch - Small / Bonnet, Headlight - Scratch - Small / Roof - Scratch - Minimal |

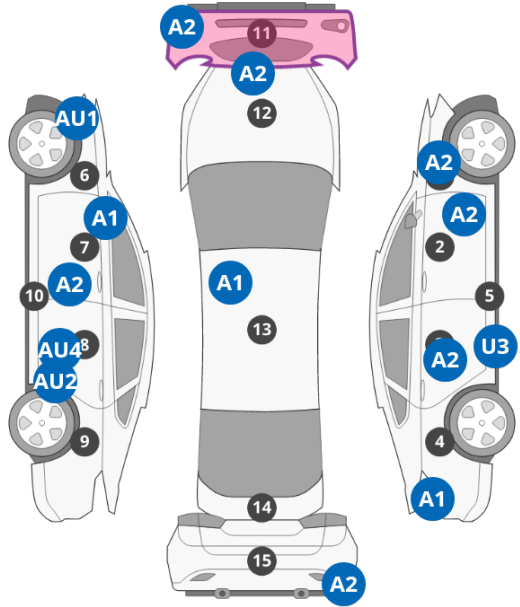
| Inspector Notes |
|---|
| with warranty booklet ,with jack and tools, with spare tire, with LTO plate, scratches on tail light |
