## General Information

| Make | Toyota | Model | Vios |
| YOM | 2024 | Odo Meter Reading | 15,042 |

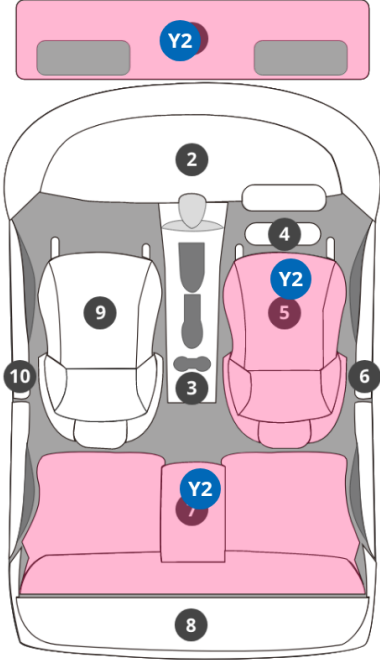
| Interior Evaluation : <span style="color: red; font-weight: bold;">A</span> | Exterior Evaluation : <span style="color: red; font-weight: bold;">D</span> |
| <p><b>Remarks</b></p> <p>(R) Front Seat - Grime - Small / Rear Seat - Grime - Small / Ceiling - Grime - Small</p> | <p><b>Remarks</b></p> <p>(R) Front Fender, Molding - Dent - Small / (R) Mirror - Scratch - Minimal / (R) Front Door, Molding - Scratch - Small / (R) Rear Door, Molding - Dent - Medium / (R) Rear Fender, Molding - Scratch &amp; Dent - Small / Rear Bumper, Lamps, Panels - Scratch - Small / Trunk Hood, Rear Gate - Scratch - Minimal / (L) Rear Fender, Molding - Scratch - Minimal / (L) Rear Door, Molding - Scratch - Minimal / (L) Front Door, Molding - Scratch - Small / Roof - Scratch - Minimal / (L) Mirror - Scratch - Medium / (L) Front Fender, Molding - Scratch - Small / Front Bumper, Grille, Lamps - Scratch - Large / Bonnet, Headlight - Scratch - Small</p> |
