General Information

Make	Toyota	Model	Vios
YOM	2024	Odo Meter Reading	12,603
Registration No.	NHR3094	Chassis No.	PA1B18F31P4228098
CC	1.3	Transmission	CVT
Fuel Type	Gas	Type of Body	Sedan
Colour	Red Mica Metallic

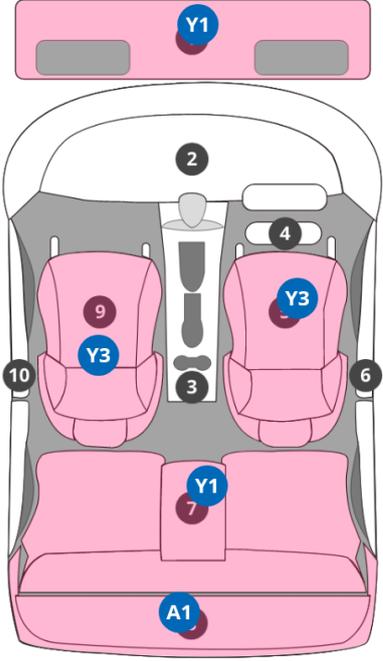
Interior Evaluation : B	Exterior Evaluation : B

<p>a : Cut, Fray d : Loose, Deformed k : Animal Hair s : Smell t : Cigarette Burns x : Defective y : Stain</p>

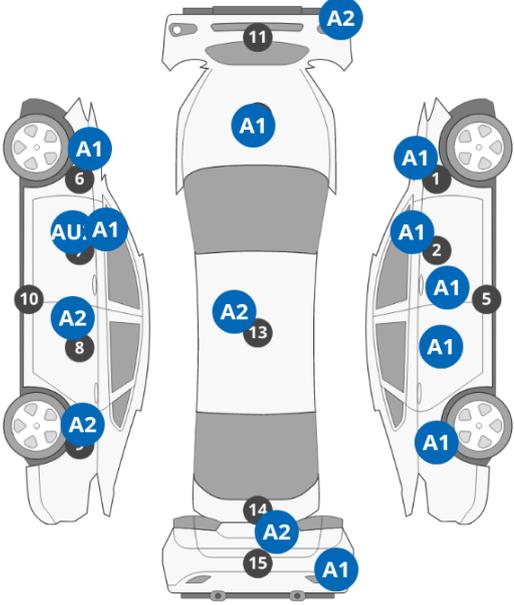
<p>A : Scratch AU : Scratch & Dent B : Modified C : Corrosion G : Stone chip P : Faded S : Rust SC : Rust & Corrosion U : Dent X : Defective Y : Crack, Gap</p>
<p>Remarks (R) Front Seat - Grime - Medium / Trunk Room - Worn, Scratch, Cut, Crack - Minimal / Rear Seat - Grime - Minimal / Ceiling - Grime - Minimal / (L) Front Seat - Grime - Medium</p>	<p>Remarks (R) Front Fender, Molding - Scratch - Minimal / (R) Front Door, Molding - Scratch - Minimal / (R) Mirror - Scratch - Minimal / (R) Rear Door, Molding - Scratch - Minimal / Roof - Scratch - Small / (R) Rear Fender, Molding - Scratch - Minimal / Rear Bumper, Lamps, Panels - Scratch - Minimal / Trunk Hood, Rear Gate - Scratch - Small / (L) Rear Fender, Molding - Scratch - Small / (L) Rear Door, Molding - Scratch - Small / (L) Front Door, Molding - Scratch & Dent - Small / (L) Mirror - Scratch - Minimal / Front Bumper, Grille, Lamps - Scratch - Small / Bonnet, Headlight - Scratch - Minimal / (L) Front Fender, Molding - Scratch - Minimal</p>
