## General Information

| Make | Toyota | Model | Vios |

## Overall Evaluation :

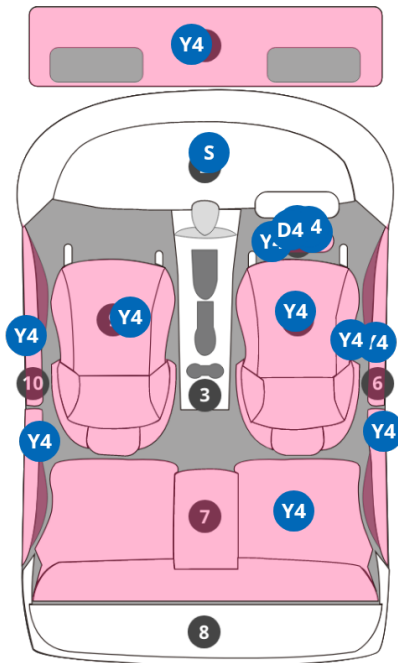
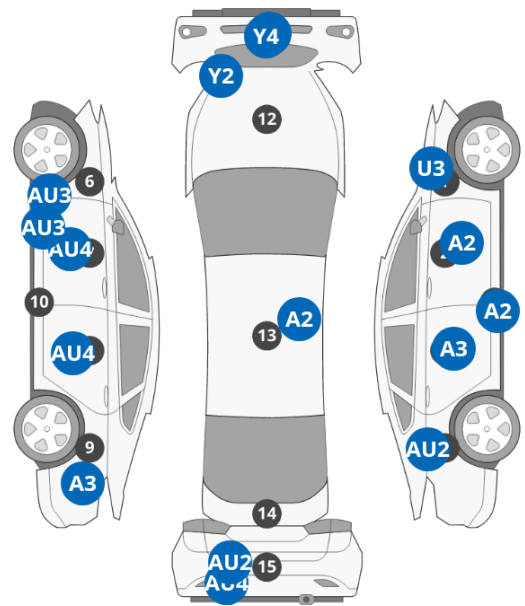
| Interior Evaluation : <b>E</b> | Exterior Evaluation : <b>E</b> |
|---|---|
| <p><b>Remarks</b></p> <p>(R) Front Seat - Grime - Large / (L) Front Seat - Grime - Large / Rear Seat - Grime - Large / Overall Interior - Smell - Yes / (L) Front Floor Mat - Grime - Large / (R) Front Floor Mat - Grime - Large / Mat Other - Grime - Large / (R) Front Trim - Grime - Large / (R) Rear Trim - Grime - Large / (L) Front Trim - Grime - Large / (L) Rear Trim - Grime - Large / (R) Front Floor Mat - Worked - Large / (R) Front Seat belt - Grime - Large / (L) Front Floor Mat - Worked - Large / Overall Interior - Worn as per age - Yes / Ceiling - Grime - Large</p> | <p><b>Remarks</b></p> <p>(R) Front Door - Repair Traces - Yes / (R) Front Fender - Repair Traces - Yes / Bonnet - Repair Traces - Yes / (L) Front Fender - Repair Traces - Yes / (L) Front Door - Repair Traces - Yes / (L) Rear Door - Repair Traces - Yes / (L) Rear Fender - Repair Traces - Yes / Trunk Hood, Rear Gate - Repair Traces - Yes / (R) Rear Fender - Repair Traces - Yes / (R) Rear Door - Repair Traces - Yes / Roof - Repair Traces - Yes / (R) Front Fender, Molding - Dent - Medium / (R) Front Door, Molding - Scratch - Small / (R) Rear Door, Molding - Scratch - Medium / (R) Step, In-panel, Side Spoiler - Scratch - Small / (R) Rear Fender, Molding - Scratch &amp; Dent - Small / Rear Bumper, Lamps, Panels - Scratch &amp; Dent - Large / Trunk Hood, Rear Gate - Scratch &amp; Dent - Small / (L) Rear Fender, Molding - Scratch - Medium / (L) Rear Door, Molding - Scratch &amp; Dent - Large / (L) Front Door, Molding - Scratch &amp; Dent - Large / (L) Step, In-panel, Side Spoiler - Scratch &amp; Dent - Medium / (L) Front Fender, Molding - Scratch &amp; Dent - Medium / Member (Bolted) - Dent - Yes / Front Bumper, Grille, Lamps - Crack, Gap - Large / Bonnet, Headlight - Crack, Gap - Small / Roof - Scratch - Small</p> |
