## General Information

| Make | Toyota | Model | Vios |

## Body / Panel Condition

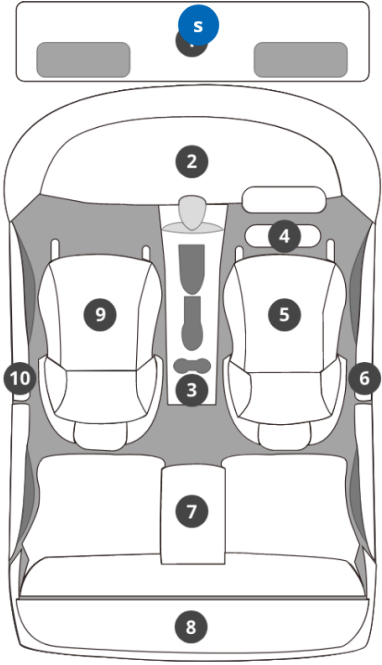
| Interior Evaluation : <b>B</b> | Exterior Evaluation : <b>A</b> |
| <b>Remarks</b><br>Overall Interior - Smell - Yes | <b>Remarks</b><br>Bonnet - Repair Traces - Yes / (L) Front Fender, Molding - Scratch - Small / Front Bumper, Grille, Lamps - Scratch - Minimal / Roof - Scratch & Dent - Minimal |

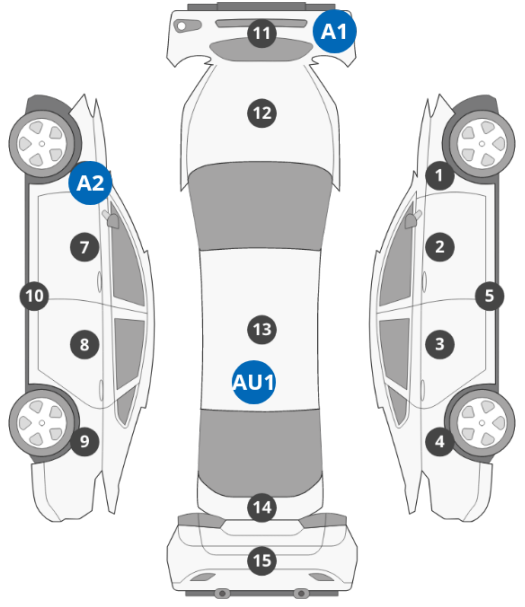
light scratches around the exterior.
