General Information

Make	Mitsubishi	Model	Mirage
YOM	2024	Odo Meter Reading	11,793
Registration No.	NIT5453	Chassis No.	PAEA13TJRPA020746
CC	1.2	Transmission	CVT
Fuel Type	Gas	Type of Body	Sedan
Colour	Red

Body / Panel Condition

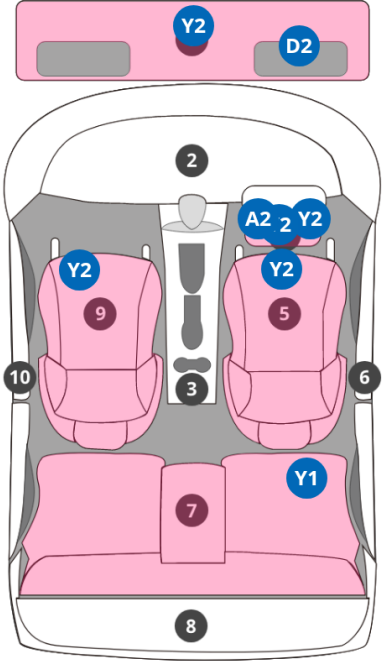
Interior Evaluation : B	Exterior Evaluation : D

<p>a : Cut, Fray d : Loose, Deformed k : Animal Hair s : Smell t : Cigarette Burns x : Defective y : Stain</p>

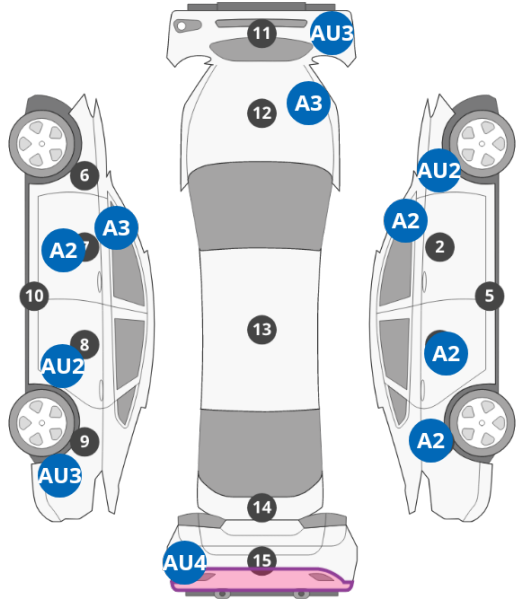
<p>A : Scratch AU : Scratch & Dent B : Modified C : Corrosion G : Stone chip P : Faded S : Rust SC : Rust & Corrosion U : Dent X : Defective Y : Crack, Gap</p>
<p>Remarks Ceiling - Grime - Small / (R) Front Seat - Grime - Small / (R) Front Floor Mat - Grime - Small / Rear Seat - Grime - Minimal / Mat Other - Grime - Small / (L) Front Floor Mat - Cut, Crack - Small / (L) Front Seat - Grime - Small / Sunvisor, Sunglass Holder - Crinkle - Small</p>	<p>Remarks (R) Front Door - Repair Traces - Yes / (L) Rear Door - Repair Traces - Yes / (L) Rear Fender - Repair Traces - Yes / Rear Bumper, Lamps, Panels - Repair mark - Yes / Rear Bumper, Lamps, Panels - Scratch & Dent - Large / (L) Rear Fender, Molding - Scratch & Dent - Medium / (L) Rear Door, Molding - Scratch & Dent - Small / (L) Mirror - Scratch - Medium / (R) Front Fender, Molding - Scratch & Dent - Small / (R) Mirror - Scratch - Small / (R) Rear Door, Molding - Scratch - Small / (R) Rear Fender, Molding - Scratch - Small / Bonnet, Headlight - Scratch - Medium / Front Bumper, Grille, Lamps - Scratch & Dent - Medium / (L) Front Door, Molding - Scratch - Small</p>
