## General Information

| Make | Mitsubishi | Model | Mirage |
| YOM | 2019 | Odo Meter Reading | 59,799 |
| Registration No. | NFT4304 | Chassis No. | PAEA13TJKKA012603 |

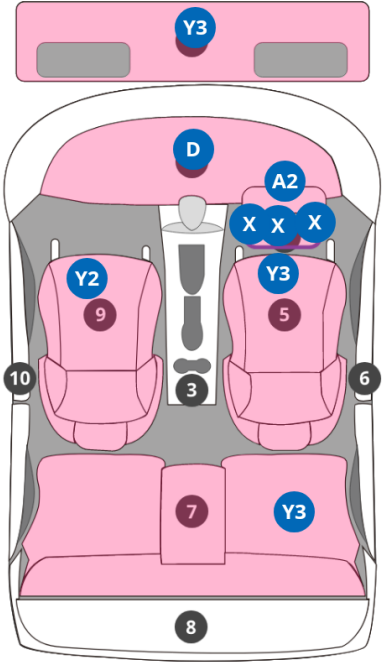
| Interior Evaluation : <b>B</b> | Exterior Evaluation : <b>D</b> |
|---|---|
| <p><b>Remarks</b></p> <p>Ceiling - Grime - Medium / Mat Other - Missing - Yes / (R) Front Floor Mat - Missing - Yes / (L) Front Floor Mat - Missing - Yes / Dashboard - Traces of Adhesive Tape - Yes / (R) Front Seat - Grime - Medium / Rear Seat - Grime - Medium / (L) Front Seat - Grime - Small / Steering Wheel - Worn, Peel, Crack - Small</p> | <p><b>Remarks</b></p> <p>(R) Front Door - Repair Traces - Yes / (R) Front Fender - Repair Traces - Yes / Bonnet - Repair Traces - Yes / (L) Front Fender - Repair Traces - Yes / (L) Front Door - Repair Traces - Yes / (L) Rear Fender - Repair Traces - Yes / Trunk Hood, Rear Gate - Repair Traces - Yes / (R) Rear Fender - Repair Traces - Yes / Roof - Repair Traces - Yes / Rear Bumper, Lamps, Panels - Scratch &amp; Dent - Large / (L) Rear Fender, Molding - Scratch &amp; Dent - Large / (L) Rear Door, Molding - Scratch &amp; Dent - Small / (L) Front Door, Molding - Scratch &amp; Dent - Minimal / (L) Front Fender, Molding - Scratch &amp; Dent - Small / Bonnet, Headlight - Scratch - Small / Front Bumper, Grille, Lamps - Scratch &amp; Dent - Medium / (R) Mirror - Scratch - Minimal / (R) Front Door, Molding - Dent - Minimal / (R) Rear Fender, Molding - Scratch - Large / (R) Rear Door, Molding - Scratch - Small</p> |

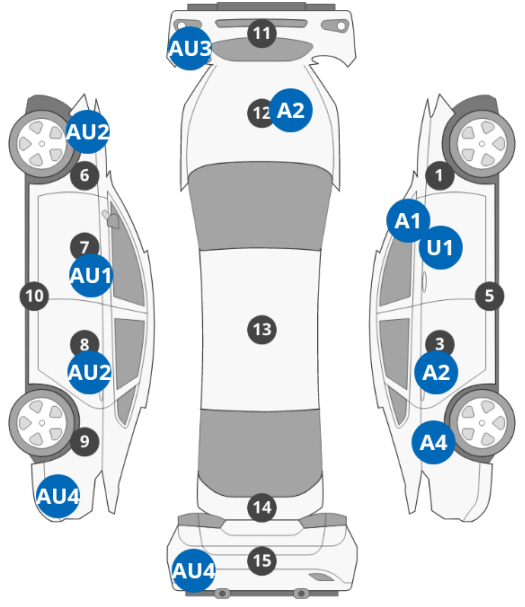
| Inspector Notes |
|---|
| Crack taillight. Gap at front and rear bumper. With warranty booklet, spare tire and jack. Without tools and seat cover. 1 key. With LTO plate |
