## General Information

| Make | Toyota | Model | Vios |

## Body / Panel Condition

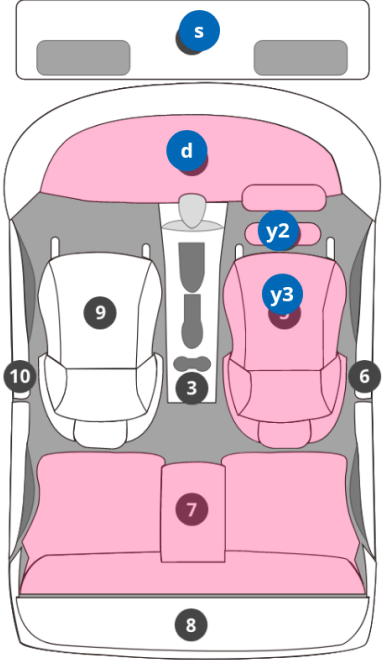
| <b>Remarks</b><br>Overall Interior - Smell - Yes / Dashboard - Traces of Adhesive Tape - Yes / (R) Front Seat - Grime - Medium / (R) Front Floor Lag - Grime - Small / Rear Seat - Grime - Medium | <b>Remarks</b><br>Front Bumper, Grille, Lamps - Scratch - Medium / (L) Front Door, Molding - Scratch - Minimal / (L) Rear Door, Molding - Scratch - Small / (L) Rear Fender, Molding - Dent - Minimal / Rear Bumper, Lamps, Panels - Scratch - Small / (R) Rear Fender, Molding - Rust, Corrosion - Minimal / (R) Front Door, Molding - Scratch - Small / Bonnet, Headlight - Scratch - Minimal / Trunk Hood, Rear Gate - Scratch & Dent - Minimal |

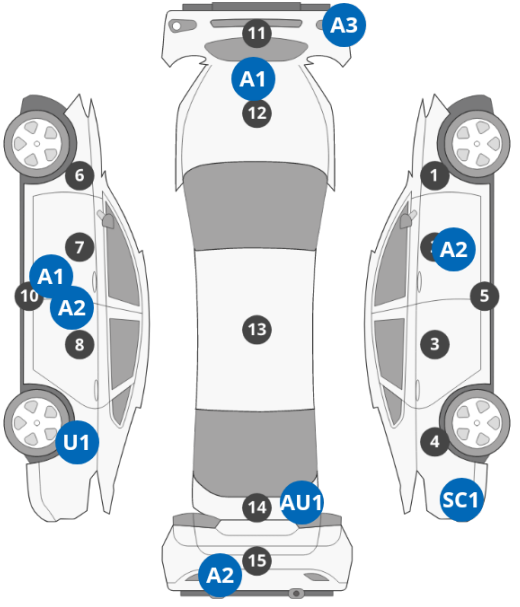
| swirlmarks and hairline scratches around the exterior. |
